**On the Mechanical Behavior of Strain
Hardening Cementitious Composites
(SHCC) under Combined and Impact
Loading**

Tese de Doutorado

Thesis presented to the Programa de Pós-Graduação
em Engenharia Civil of PUC-Rio in partial fulfillment
of the requirements for the degree of Doutor em
Ciências – Engenharia Civil.

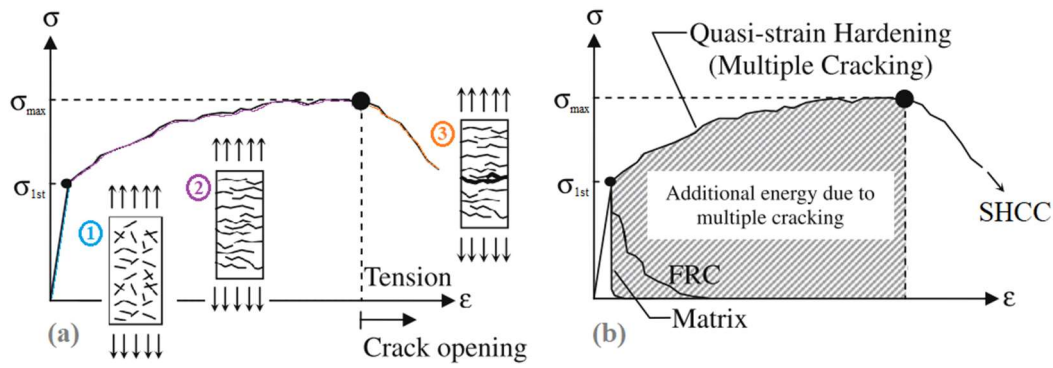
Fig. 2.1 – Mechanical behavior of SHCC [19]: (a) Typical stress-strain curve; (b) SHCC additional energy absorption potential due multiple cracking process.

loads at quasi-static strain rates [1,21,22]. Their pronounced strain capacity is due to the formation of multiple-cracks with exceptional Crack-Mouth Opening Displacement (CMOD) control, with values ranging from 20–100 μm width [23–25]. This multiple-cracking process grants the specimen a stable cracking propagation at the macroscopic level, which reflects in a pseudo-ductile post-cracking behavior. The establishment of this process is enabled by the optimized crack-bridging action of short, thin, and randomly distributed fibers [21]. As shown in the stress-strain curve in Fig. 2.1a, a typical stress-strain curve of this composite presents three stages:

- (1) First, a clear linear/elastic stretch can be noticed, mainly influenced by the mechanical properties of the cement-based matrix. During this phase, the composite is undamaged, and no cracks had occurred.

- (2) Next, the second branch corresponds to the multiple-cracking stage, which is the most relevant phase of this type of composite. A sort of plateau is observed, starting with the first crack of the matrix, which substantially reduces the composite's rigidity, and finishing with the moment when the composite starts to significantly lose its load-bearing capacity. Despite the reduction of the Young's Modulus, due to the exceptional crack-bridging performance, the composite's load-bearing capacity is at times sustained, or more commonly, expanded during the multiple-cracking process.

- (3) At last, the third segment corresponds to the critical-crack localization, commonly referred to as the "softening phase". This stage is defined by the local failure of the crack-bridging process. At this stage, the composite rapidly loses its load-bearing capacity, presenting or not any additional strain capacity. For all purposes, the strain capacity value of an SHCC is assumed as the boundary value between the second and third segments.

Fig. 2.1b highlights the additional energy absorption capacity of SHCC when compared to regular cement-based matrices, which present brittle behavior, and, the strain-softening performance of FRC. SHCC presents a distinct matrix dosage, constituted only by fine-grained inputs which directly affect its fracture energy and the adherence with the fibers [10,26,27]. These characteristics allow this material to obtain much higher levels of strain than other fiber-reinforced cementitious composites.

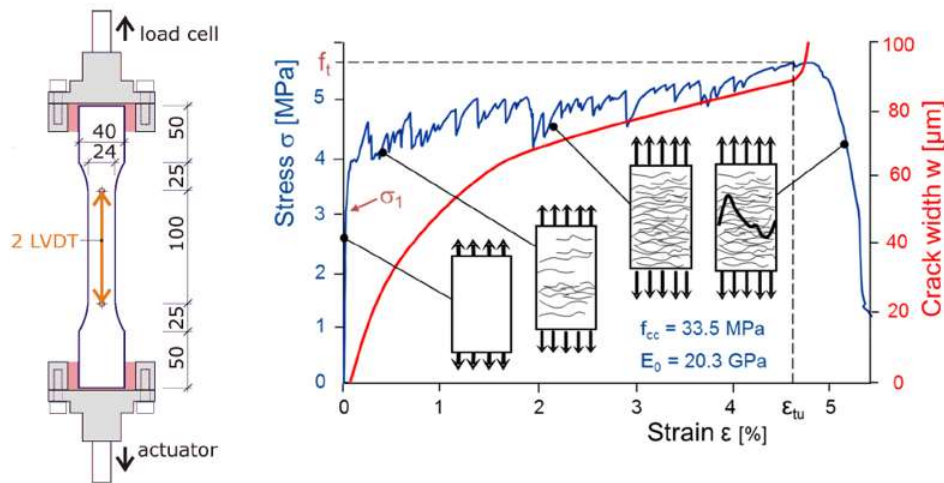
Fig. 2.3 – Typical strain hardening behavior of SHCC reinforced with PVA fibers during a direct tensile test [34].

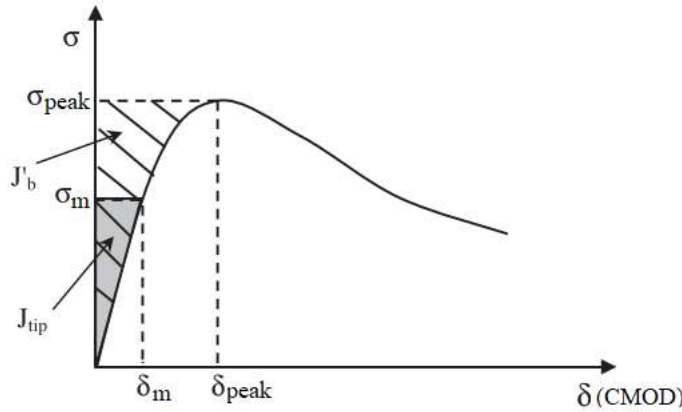
Fig. 2.5 – Typical stress-displacement curve of SHCC [10,46,51,52].

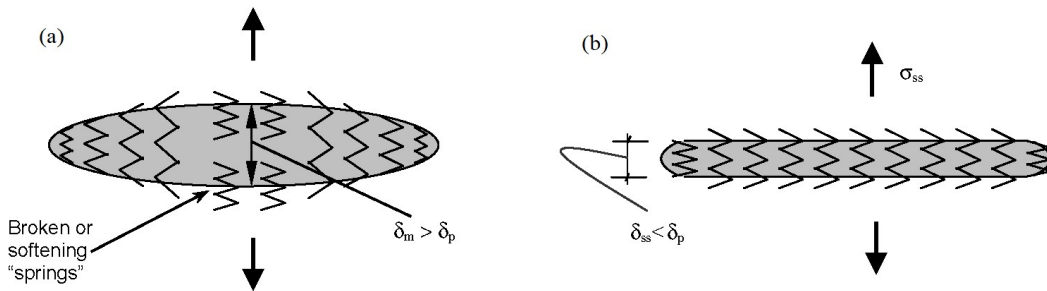
Fig. 2.6 – Types of crack derived from cross-sectional tension stress [56]: (a) Griffith-type, with values of CMOD (δ_m) exceeding the critical size (δ_p); (b) Flat, or steady-state type, with CMOD (δ_{ss}) smaller than the critical value on the whole length of the crack.

High complementary energy values result in flat-type cracks (not Griffith-type), which enable regular stress states (without concentration) through the fractured surface [14,49]; see Fig. 2.6. The crack-width control due to the bridging of the fibers enables the formation of new cracks, which results in a macroscopic steady-state non-elastic deformation.

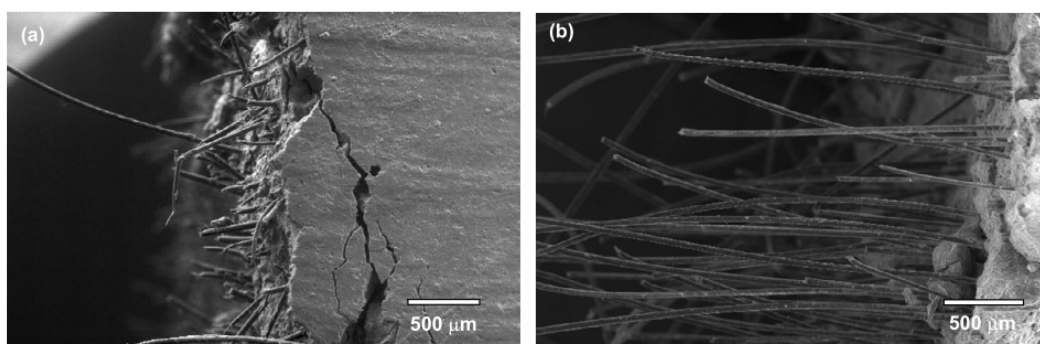
Fig. 2.7 – Failure mechanisms of SHCC at low and high strain rates: (a) fracture surface of a specimen tested at 10^{-3} s^{-1} (b) fracture surface of a specimen tested at 25 s^{-1} [23].

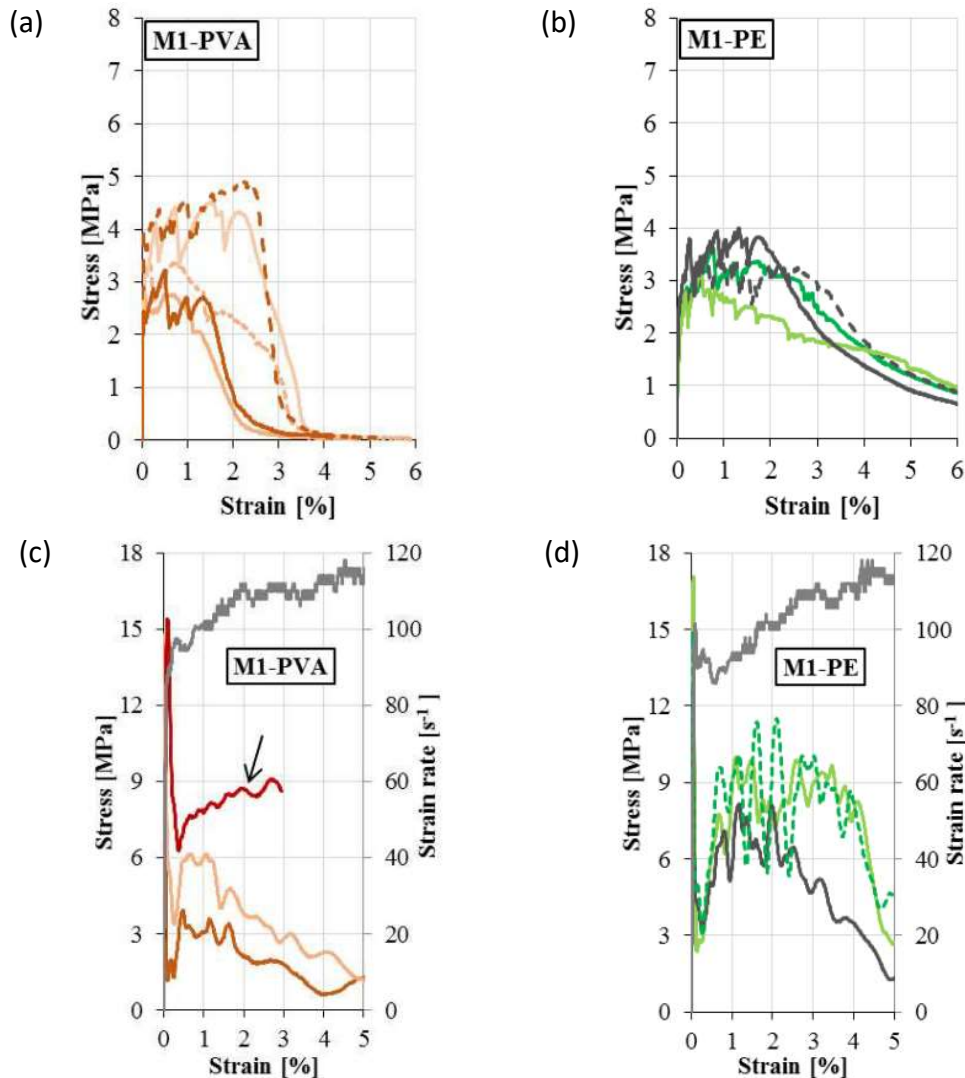
Fig. 2.8 – Stress-strain curves of normal-strength (M1) SHCC reinforced with PVA and PE fibers [63]. Curves (a) and (b) refers to quasi-static tension tests (5.10^{-4} s^{-1}); curves (c) and (d) to high-speed tension tests (120 s^{-1}). Note the different axes' limits.

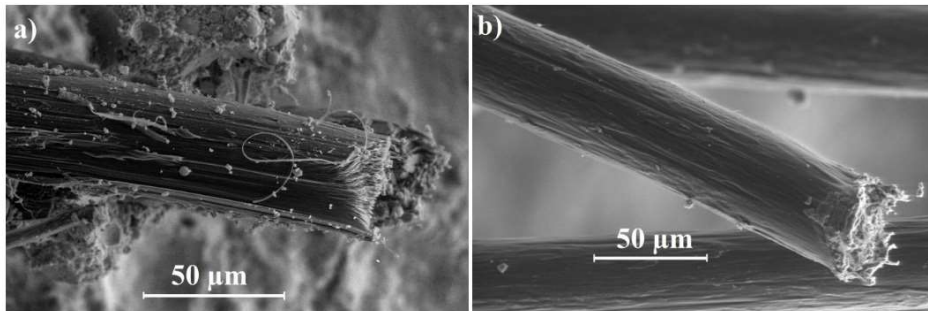
Fig. 2.9 – ESEM images of normal strength SHCC with PVA fibers [10]. Fractured surfaces of samples tested in different strain-rate regimes: (a) quasi-static; (b) dynamic.

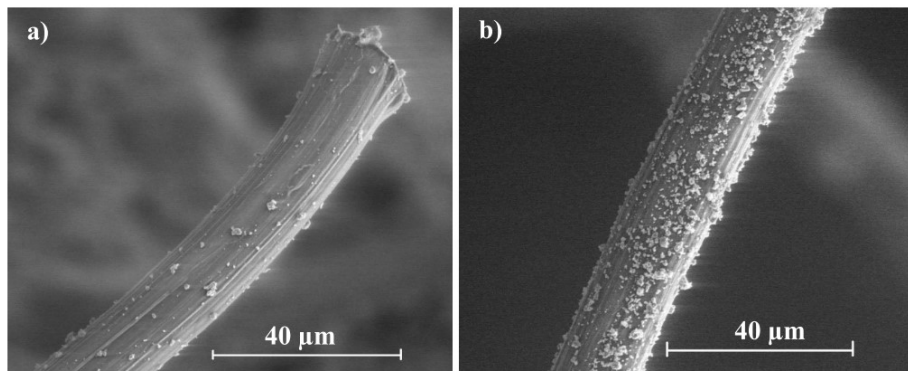
Fig. 2.10 – ESEM images of normal strength SHCC with PE fibers [10]. Fractured surfaces of samples tested in different strain-rate regimes: (a) quasi-static; (b) dynamic.

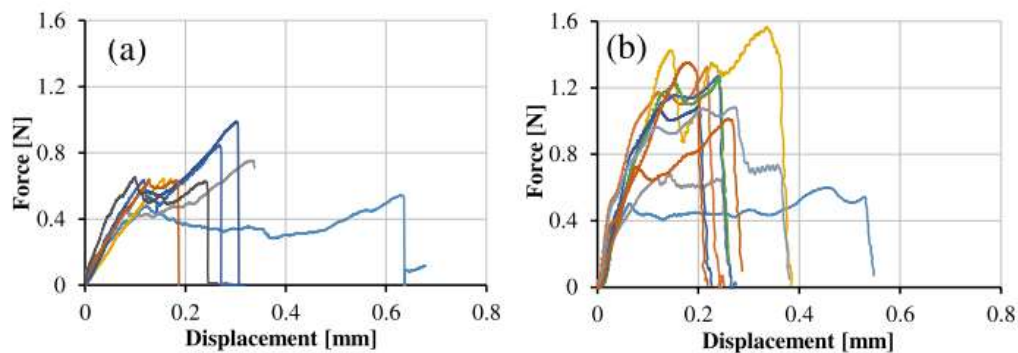
Fig. 2.11 – Pullout force *versus* displacement slip from pullout tests made with PVA fibers in normal-strength matrix with an embedded length of 2 mm under different displacement rates: (a) $5.10^{-3} \text{ mm.s}^{-1}$; (b) 5.10 mm.s^{-1} .

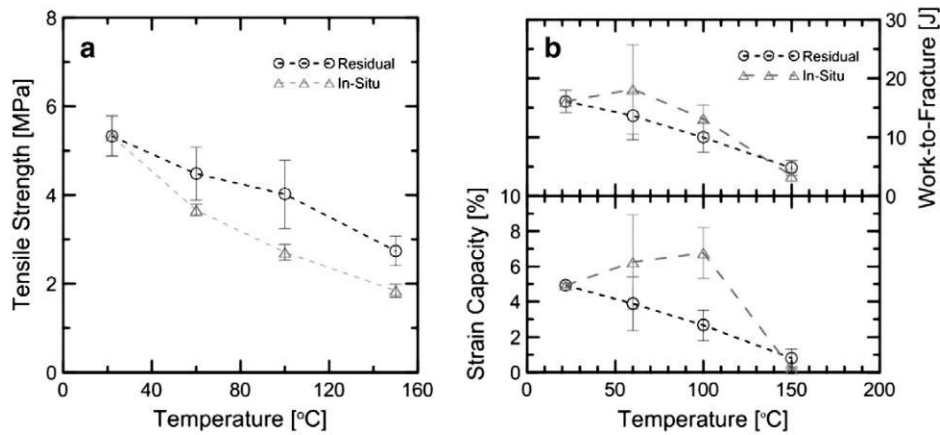
Fig. 2.13 – Effect of temperature in the tensile strength, strain capacity and work-to-fracture of PVA-SHCC tested at a quasi-static strain rate ($3 \cdot 10^{-4} \text{ s}^{-1}$) [26].

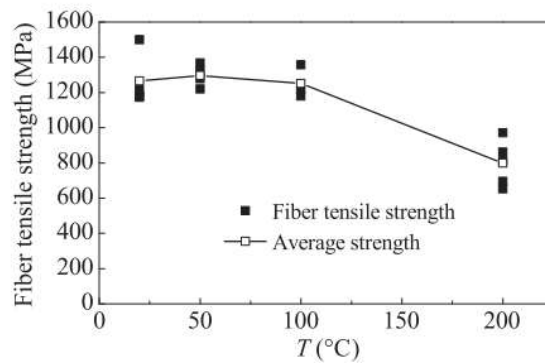
Fig. 2.14 – Effect of temperature exposure on PVA-fibers' strength [65].

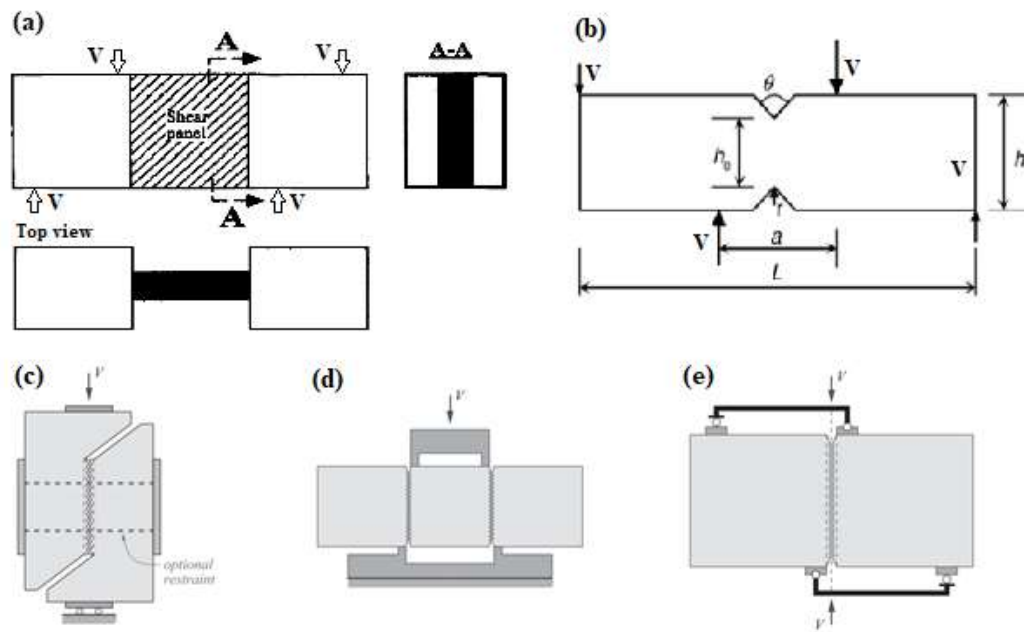
Fig. 2.15 – Test methods for shear transfer in concrete and FRC [68–70]: (a) Ohno shear beam; (b) Iosipescu beam; (c) single-plane, push-off specimen; (d) double-plane shear test regulated by the Japan Society of Civil Engineers (JSCE); (e) single-plane shear test regulated by the *fib*.

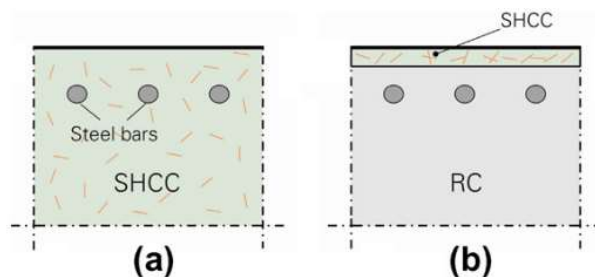
Fig. 2.17 – Possible combinations of SHCC and regular RC for steel-reinforcement protection: (a) regular matrix replacement; (b) patch-material / cover-layer [88].

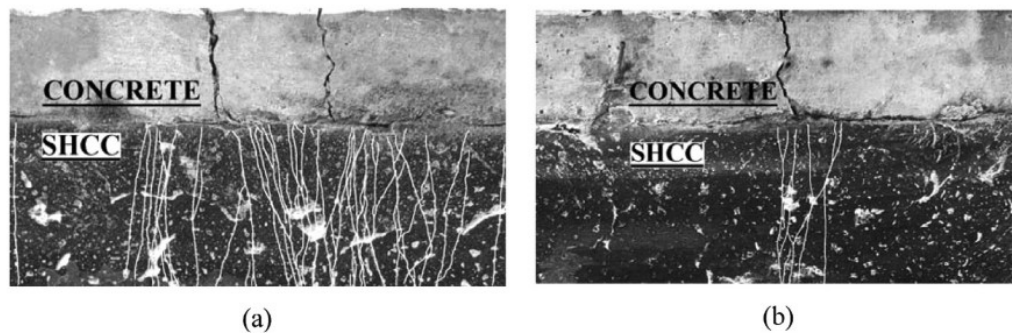
Fig. 2.18 – Bonding influence in the crack patterns of SHCC patches: (a) Good bond relates to multiple-cracking formation; (b) Bad bond relates to the patch spalling [25].

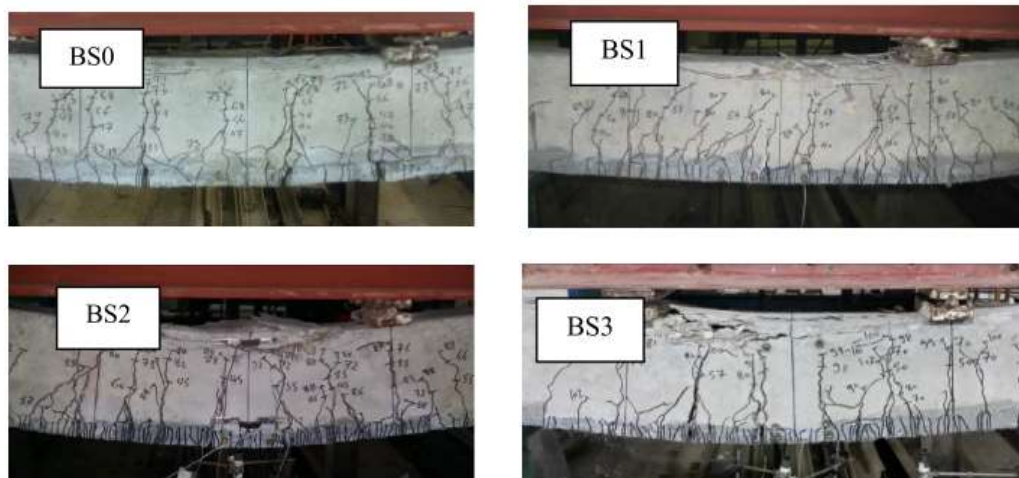
Fig. 2.19 – Crack patterns and failure modes of the beams strengthened with SHCC [17].

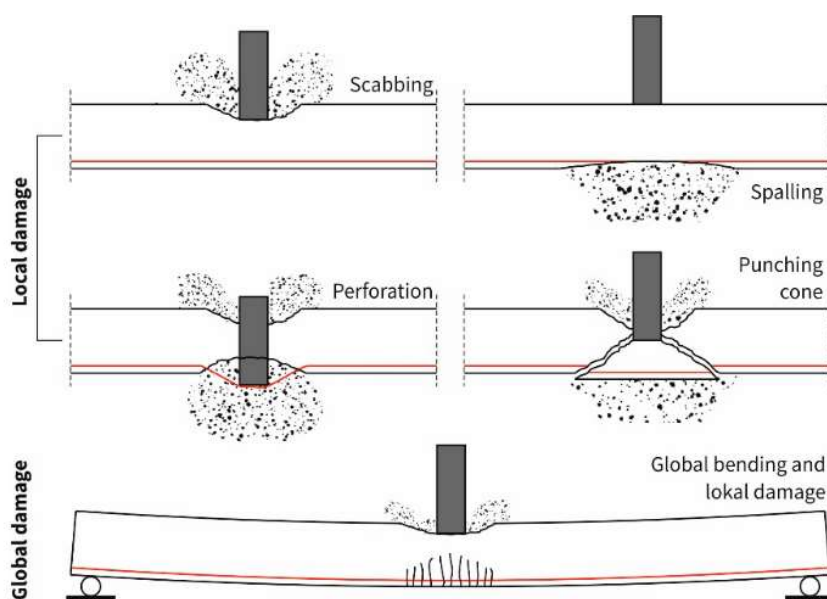
Fig. 2.20 – Summary of different types of damage on RC structures coming from impact scenarios [119,133].

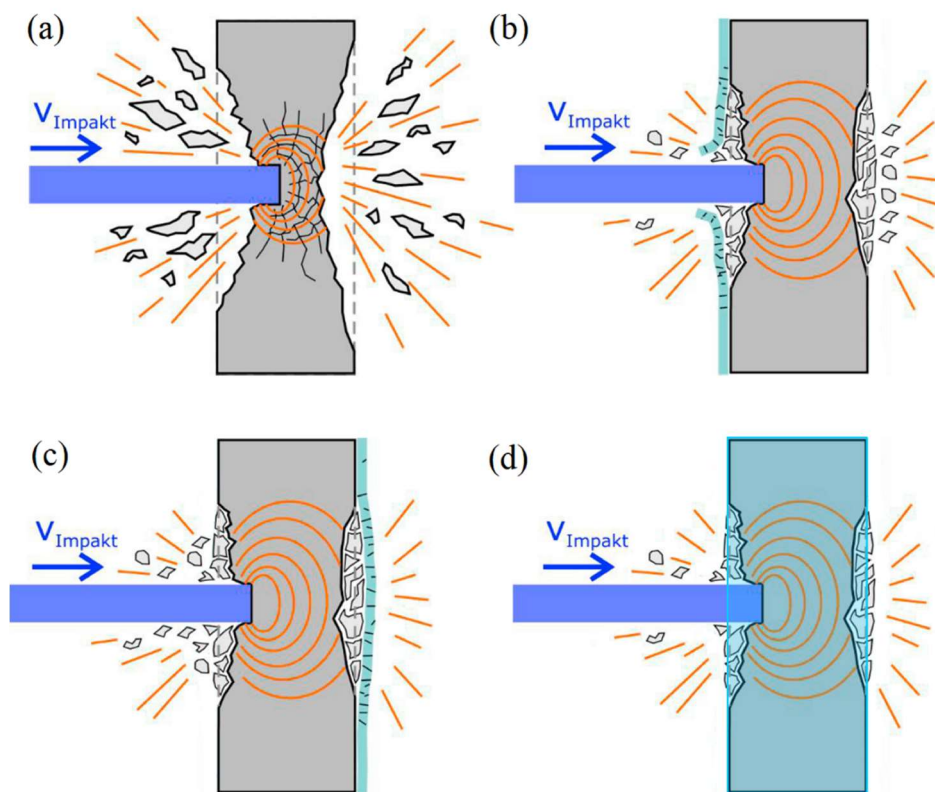
Fig. 2.22 – Impact behavior of RC members strengthened with FRC [adapted from 118]: (a) without strengthening; (b) with strengthening on the front-surface (impacted plane); (c) with strengthening on the rear-surface (opposite to the impacted plane); (d) with strengthening on the side surfaces parallel to the impactor's trajectory (side surfaces).

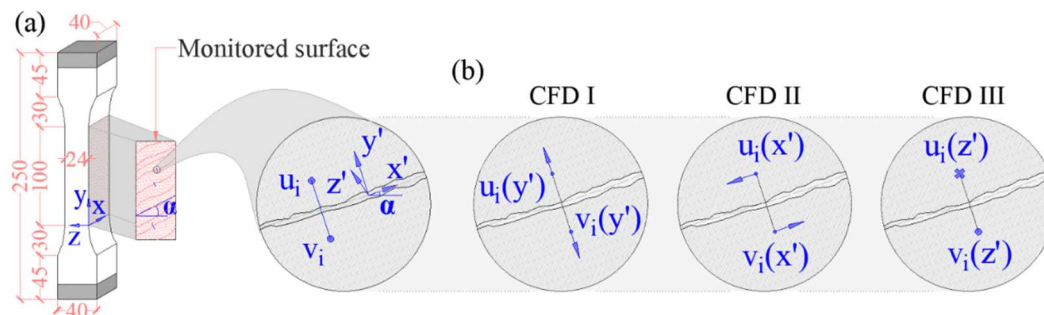
Fig. 3.2 – (a) Dumbbell-shaped specimen with dimensions in mm indicating the positions of the global (GCS) and the local coordinate systems (LCS) as well as the virtual calipers. The grey portions at the specimens' ends represent the regions embedded in the glue and encased by the metal rings. (b) Schematic representation of the assessed CFD in the DIC analysis.

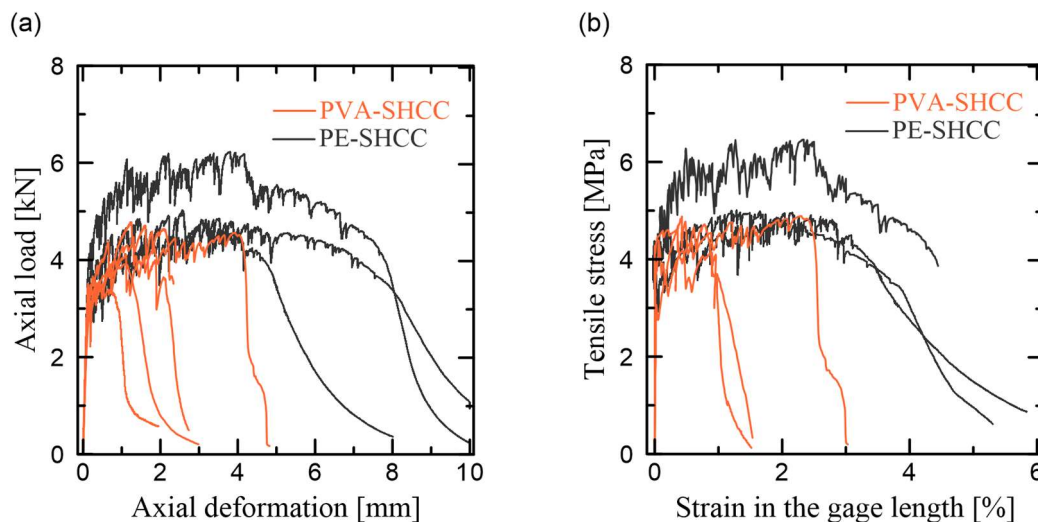
Fig. 3.4 – Uniaxial tensile behavior of PVA-SHCC and PE-SHCC: (a) load-deformation curves and (b) stress-strain curves.

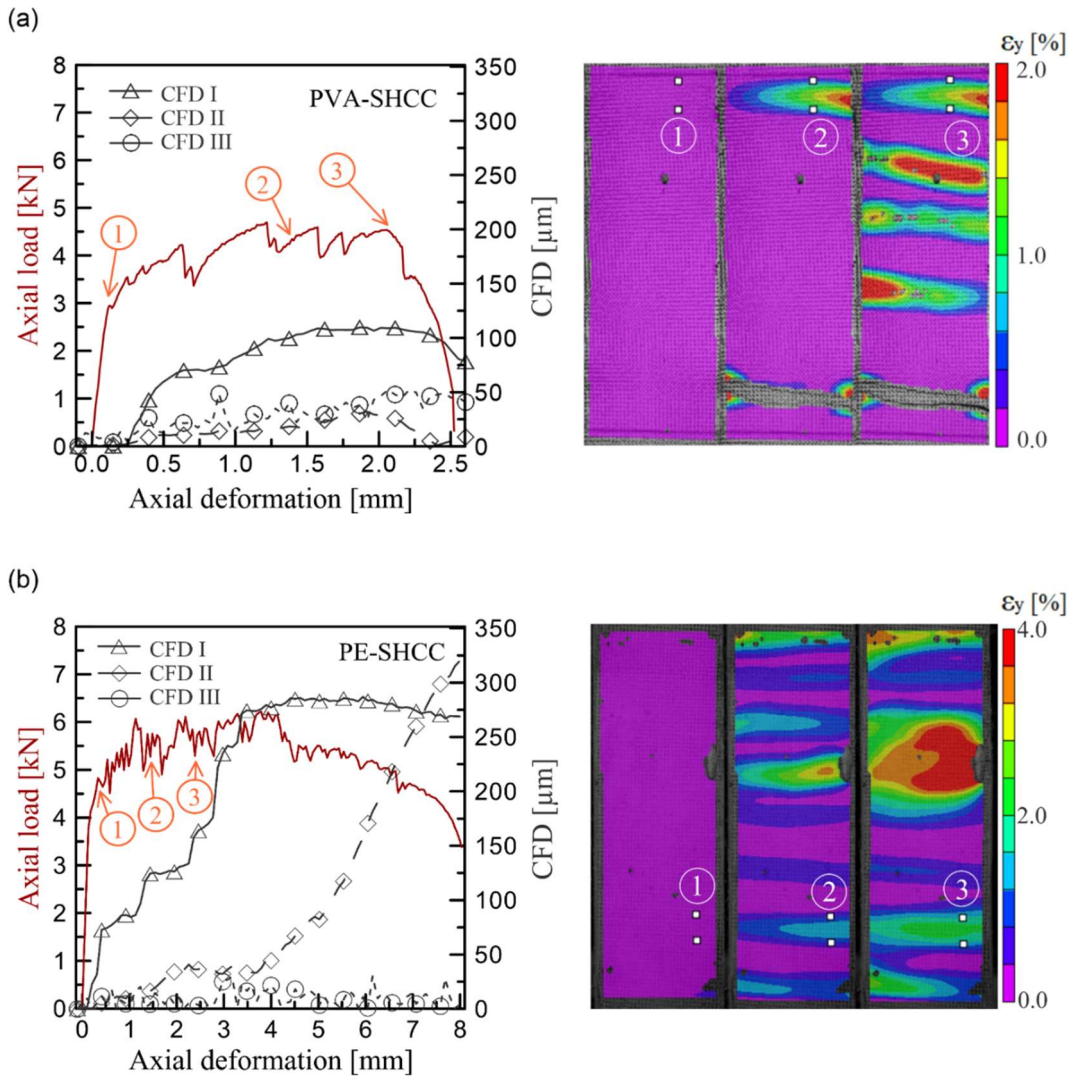
Fig. 3.5 – CFD analysis under LC1: (a) PVA-SHCC and (b) PE-SHCC. Note different x-axes (diagrams on the left) and different color scales (pictures on the right).

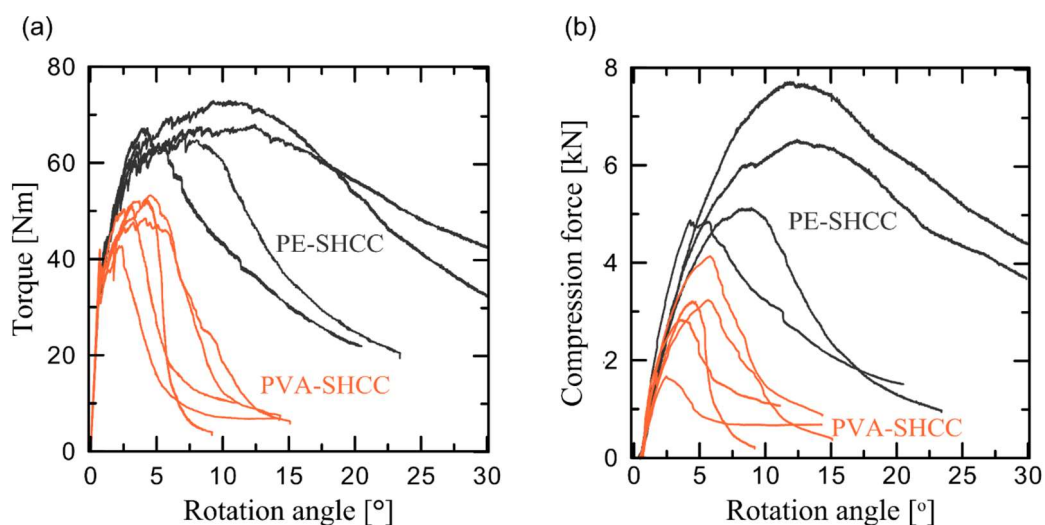
Fig. 3.6 – (a) Torque-rotation angle curves and (b) compression force-rotation angle curves of PVA-SHCC and PE-SHCC obtained in LC2.

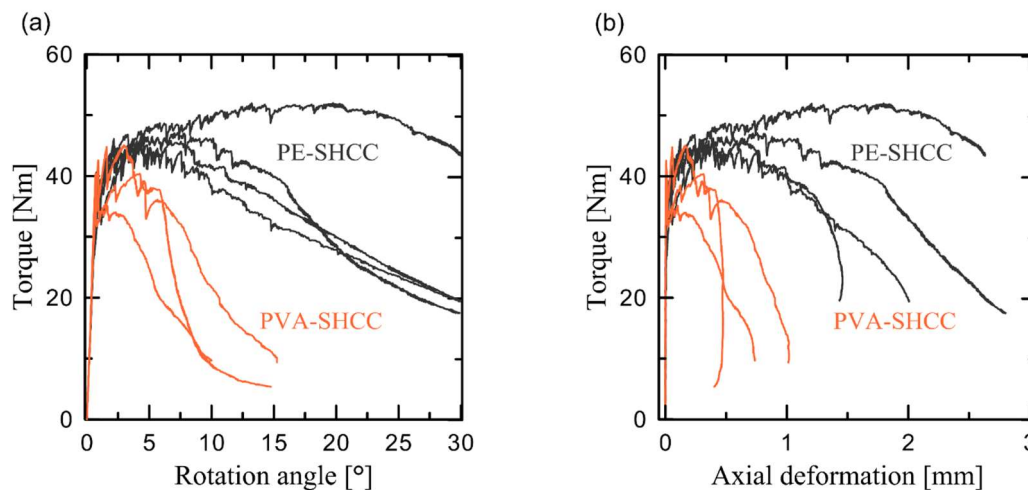
Fig. 3.8 – Mechanical behavior of PVA-SHCC and PE-SHCC under LC3: (a) torque-rotation angle curves; (b) torque-axial expansion curves.

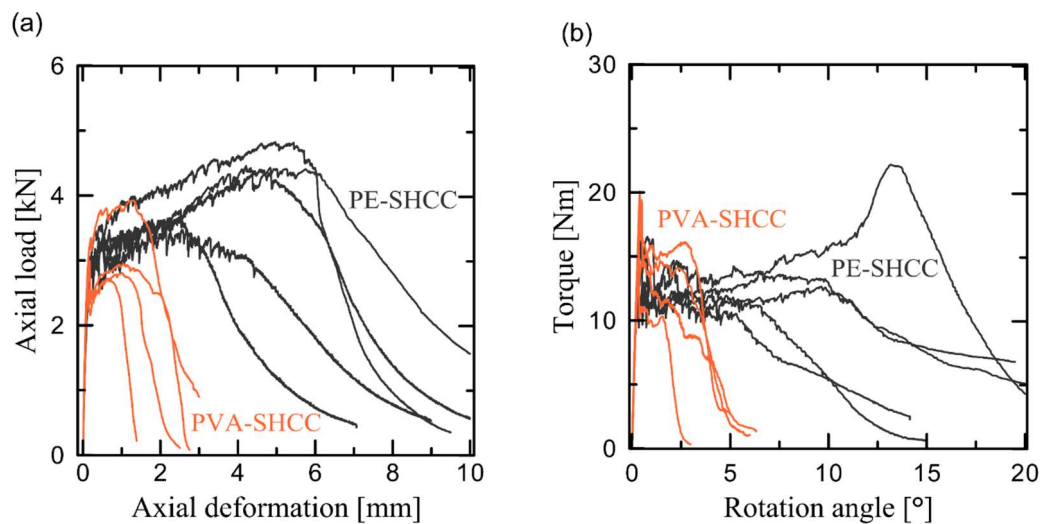
Fig. 3.10 – Behavior of PVA-SHCC and PE-SHCC under LC4: (a) axial load-deformation; (b) torque-rotation curves.

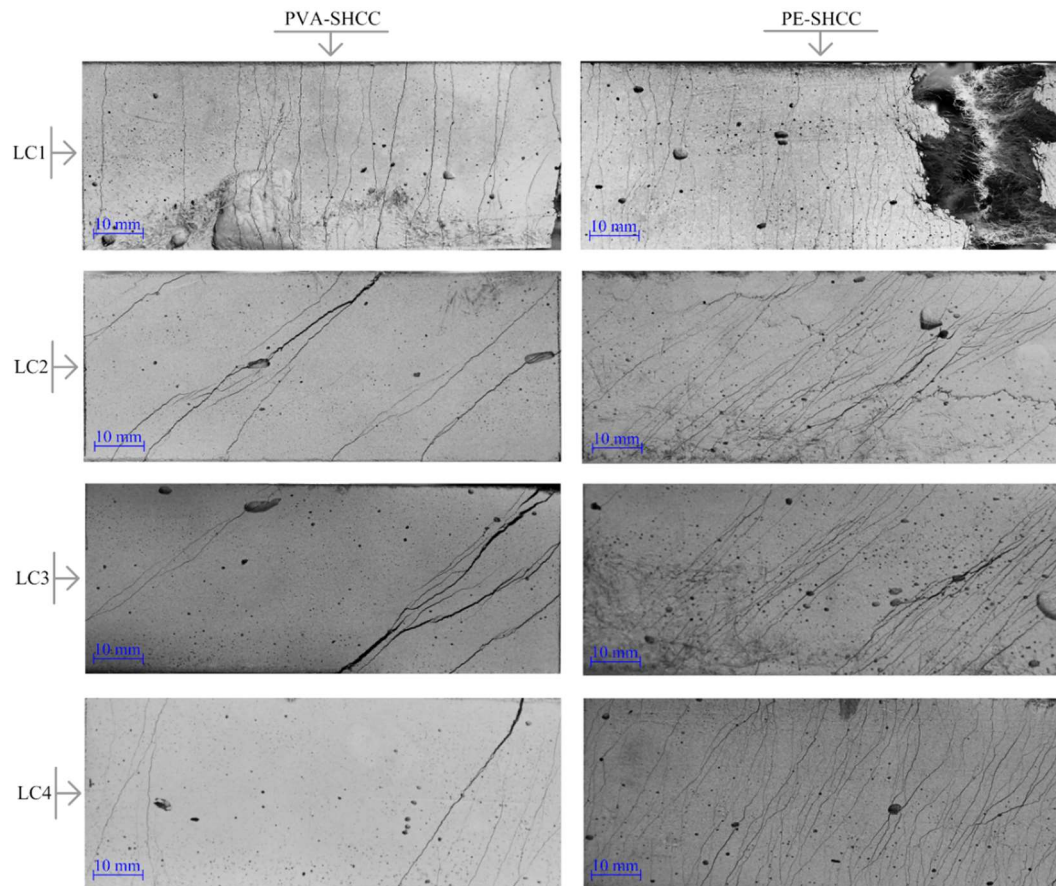
Fig. 3.14 – Multiple cracking patterns of representative specimens in each load case.

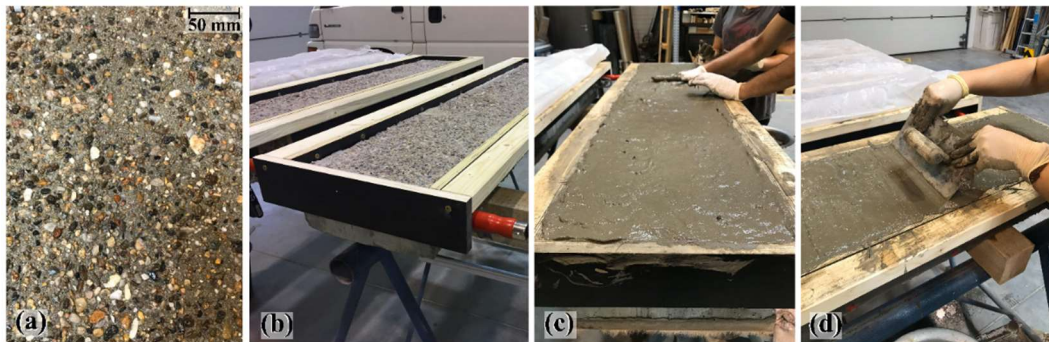
Fig. 4.2 – Casting procedures of the strengthening with SHCC: (a) Substrate preparation by washing the superficial cement-paste layer; (b) Fixation of the wood templates; (c) Molding process; (d) Surface correction.

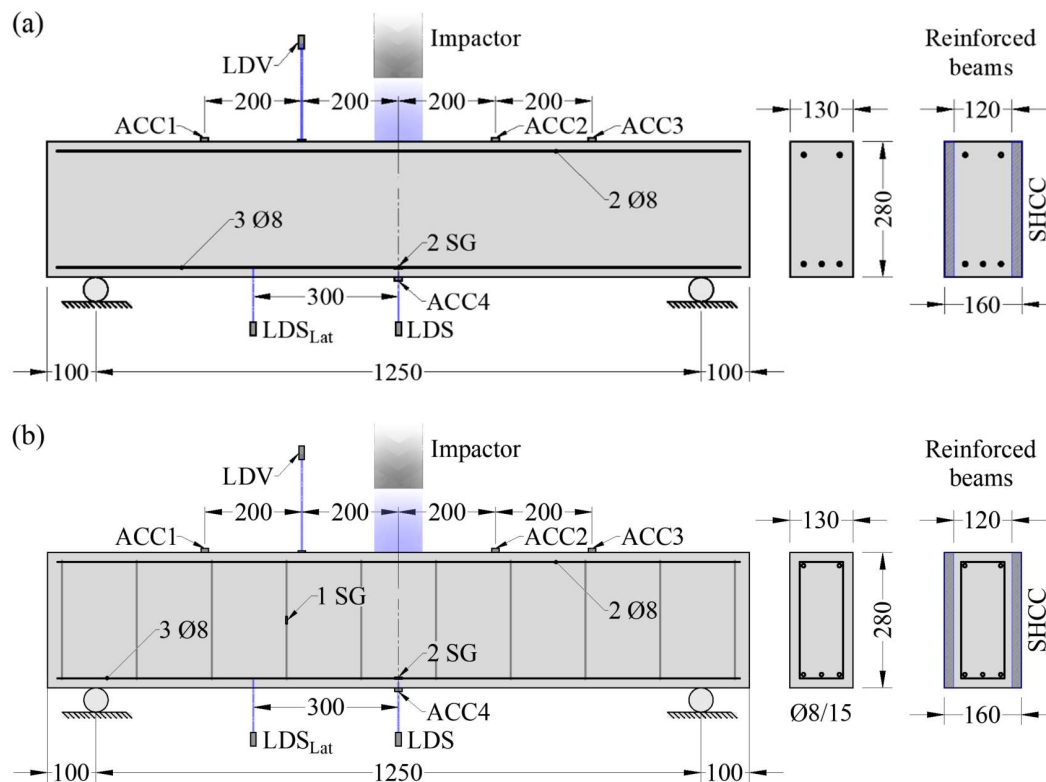
Fig. 4.3 – Geometry of the RC beams, layout of the steel reinforcement and location of the embodied instrumentation: (a) Beams without stirrups (Se); (b) Beams with stirrups (Ce). Dimensions in mm.

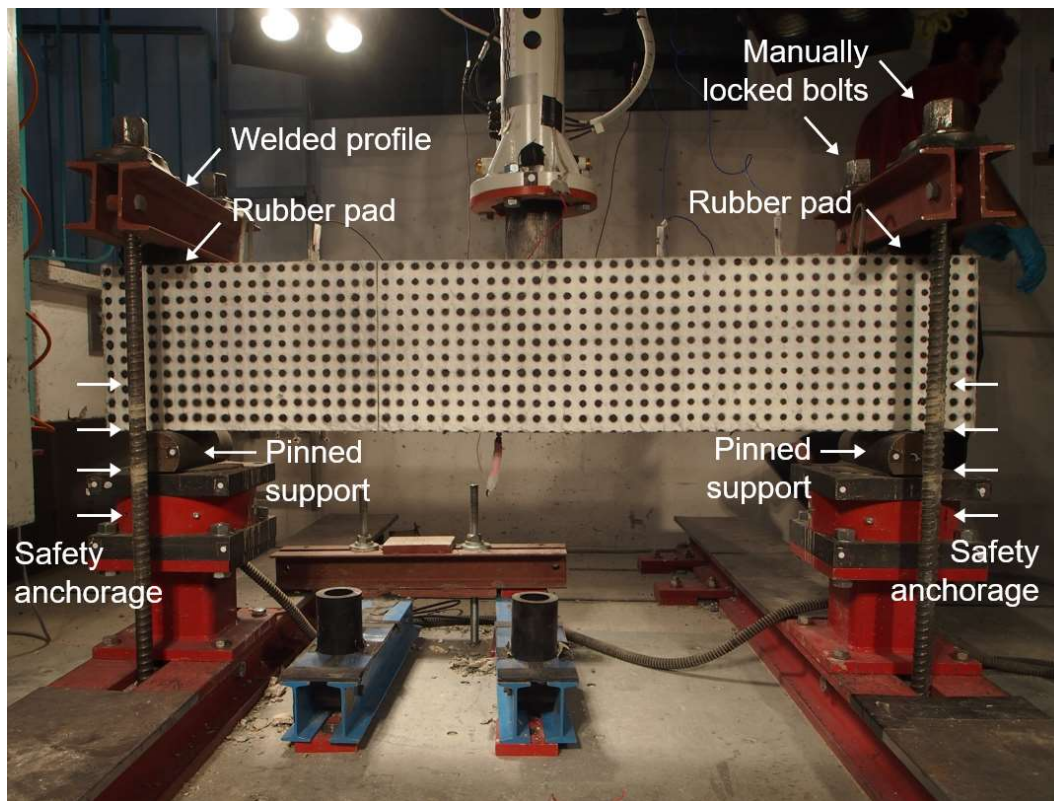
Fig. 4.4 – Testing setup's boundary conditions.

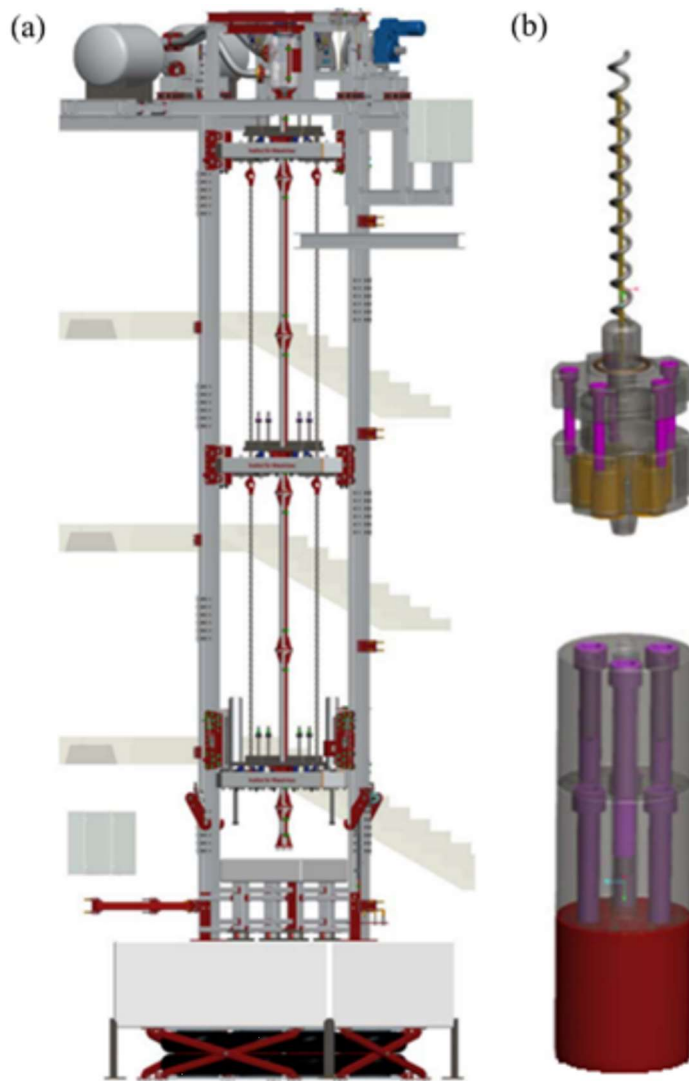
Fig. 4.6 – Accelerated configuration of the impact system [115]: (a) Schematic sketch of the testing facility; (b) Detailed image of the projectile including the retraction device.

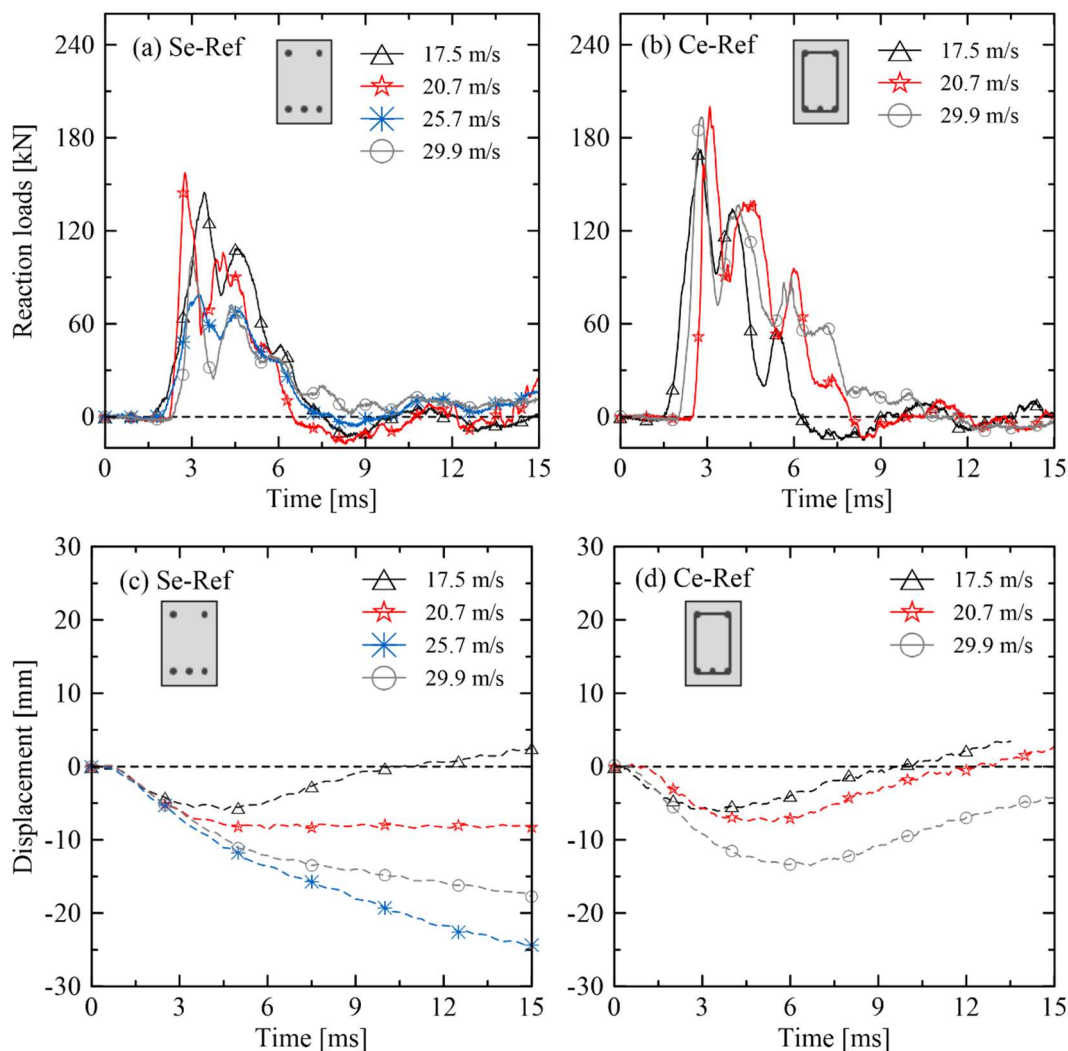
Fig. 4.9 – Time histories of the summed reaction forces measured by the load cells and the displacements obtained through the LDV during the experiments of the non-strengthened beams.

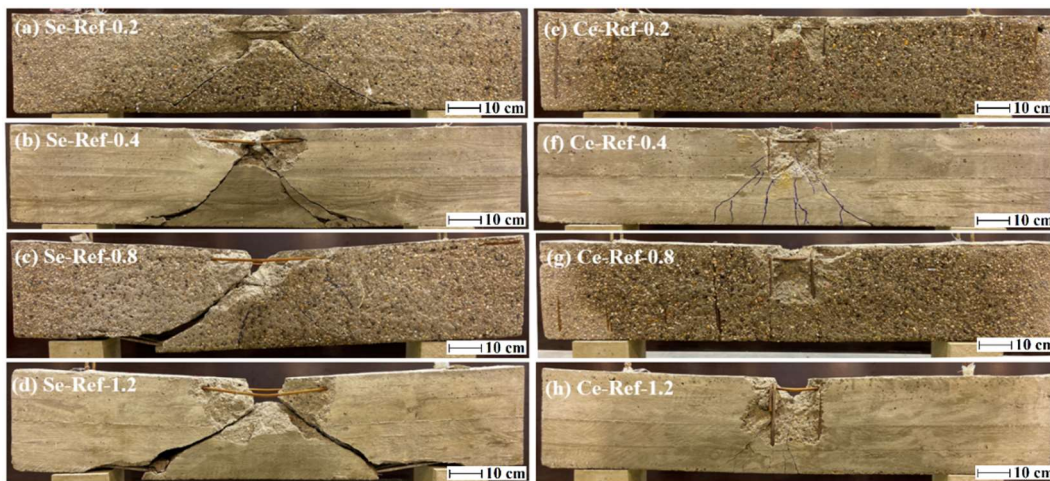
Fig. 4.13 – Damage extent in the RC beams after the impact tests with different charges.

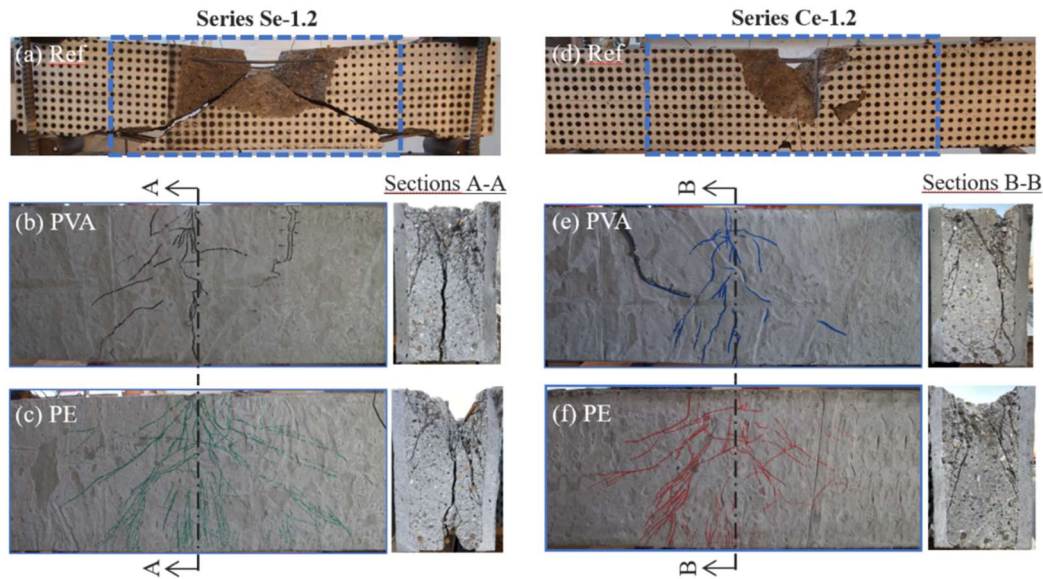
Fig. 4.20 – Comparative damage assessment of the specimens tested under 29.9 m/s: influence of the stirrups and the SHCC reinforcement: (a) Cracking pattern of the reference specimen without stirrups; (b) Highlighted cracking pattern and middle cross-section of the specimen without stirrups and strengthened with PVA-SHCC; (c) Highlighted cracking pattern and middle cross-section of the specimen without stirrups and reinforced with PE-SHCC; (d) Cracking pattern of the reference specimen with stirrups; (e) Highlighted cracking pattern and middle cross-section of the specimen with stirrups and reinforced with PVA-SHCC; (f) Highlighted cracking pattern and middle cross-section of the specimen with stirrups and strengthened with PE-SHCC.

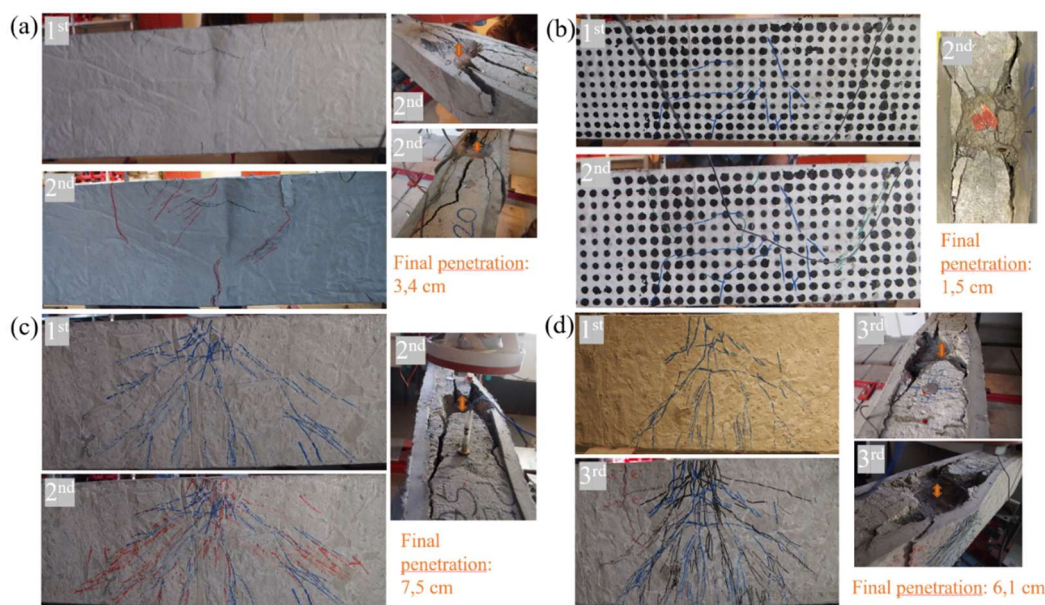
Fig. 4.21 – Lateral and upper view of the specimens impacted more than one time.

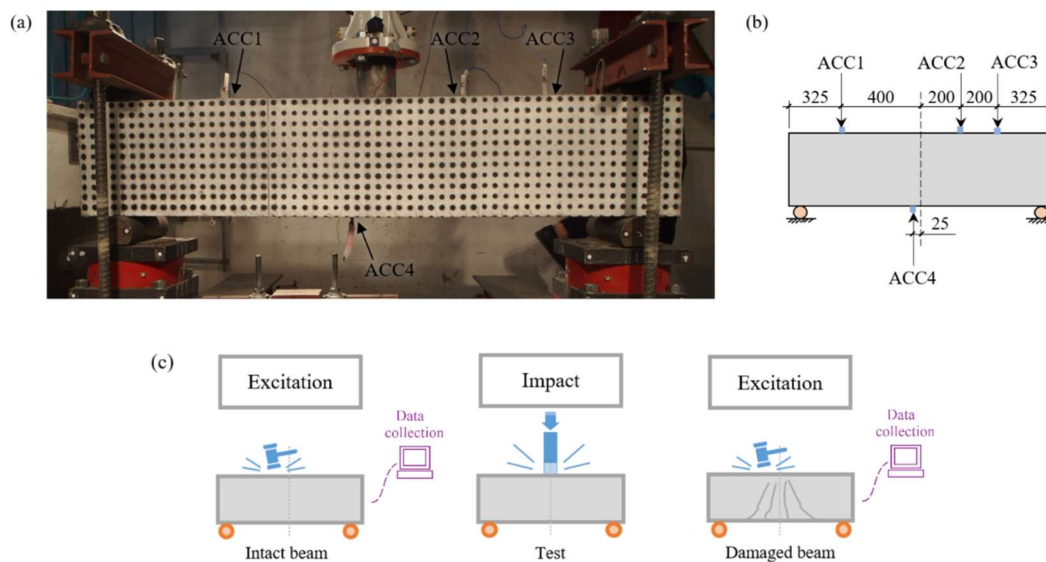
Fig. 5.2 – Test configuration: (a) View of the test set-up; (b) Illustration of the boundary conditions and positioning of the transducers (dimensions in mm); (c) Schematic representation of the measuring steps considered on the experimental modal analysis.

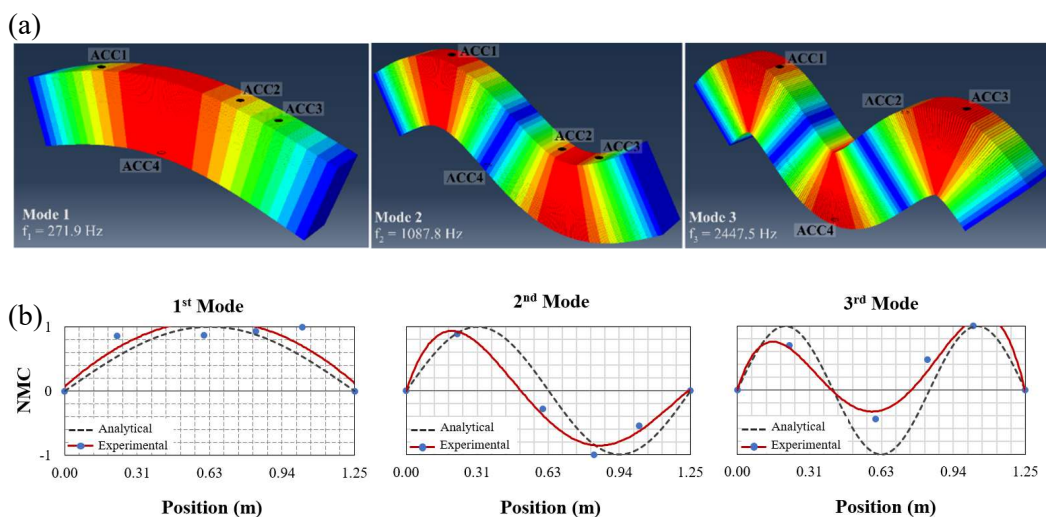
Fig. 5.4 – Three first theoretical vibrational modes with indication of the transducers' positioning (e.g. WOS-Ref): (a) mode shapes and corresponding natural frequencies obtained through numerical modeling; (b) correlation example of the NMC with the analytical formulations.

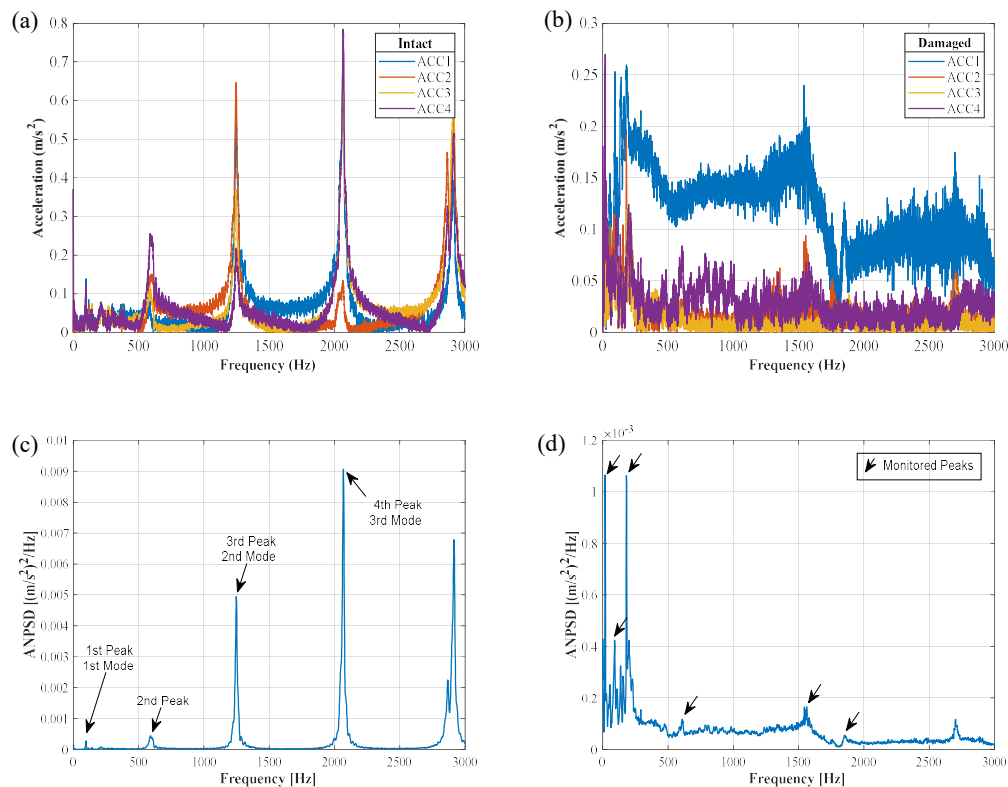
Fig. 5.6 – Typical vibration spectra for the RC specimens and natural frequencies associated with the three first vibrational modes (e.g. WOS-Ref): (a) FFT before the impact; (b) FFT after the impact; (c) ANPSD before the impact; (d) ANPSD after the impact.

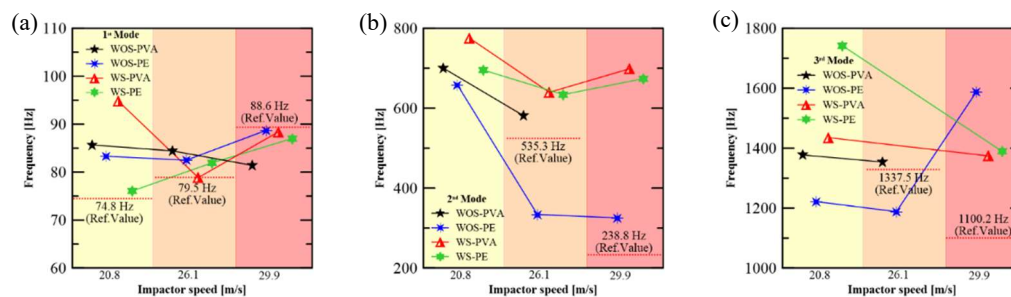
Fig. 5.9 – Average values of the natural frequencies obtained through TD and FD in function of the impactor speed regarding the SHCC damaged specimens classified by type: (a) Mode 1; (b) Mode 2; (c) Mode 3. Note different y-axes. Values on the x-axis are out of phase to improve the visualization. The reference values (Ref. Value) corresponds to the average value obtained on the damaged RC beams with stirrups (see also Table 5.5).
