**Comparing Ultrasound and Shearography  
inspections as methods to monitor and predict  
long-term damage propagation of composite  
pipeline repairs**

**Tese de Doutorado**

Thesis presented to the Programa de Pós-graduação em Engenharia de Materiais e de Processos Químicos e Metalúrgicos of PUC-Rio in partial fulfillment of the requirements for the degree of Doutor em Engenharia de Materiais e de Processos Químicos e Metalúrgicos.

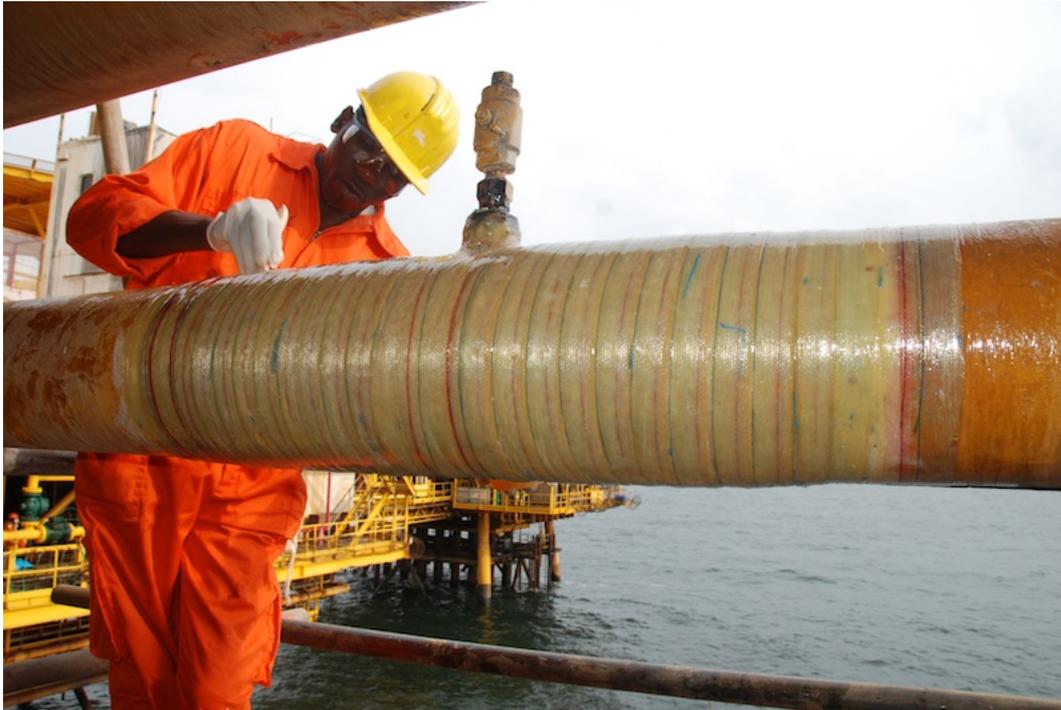
Figure 1: Technician applying a composite repair to a pipeline in an offshore vessel. The composite material is wrapped around the defective section of pipe, after the surface has been cleaned and prepared. The technician applies layers of the repair material until the desired thickness is reached. Source: [10]

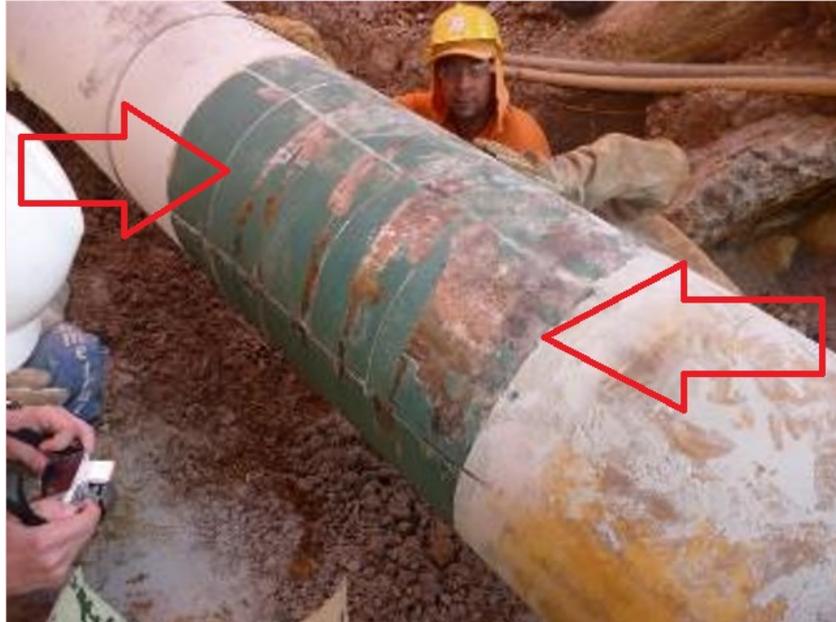
Figure 2: Corrosion beneath the repaired area after removal of the composite wrap. The green area is where the composite repair was applied and the red arrows show the corrosion propagation that lead to the repair being reprovved upon NDT inspection. Source: BAWSF, used with permission.

The degradation suffered by the repairs during operation needs to be identified and, if possible, monitored over time. Non-destructive testing (NDT) techniques are essential for pipeline repair integrity management, as they allow assessing the condition of the pipelines without causing any damage to the pipeline itself and without interrupting operation. NDTs can detect defects both at the surface and along the thickness of the material, including cracks, corrosion (Figure 2), and material degradation, which can compromise the integrity of pipelines [11,12].

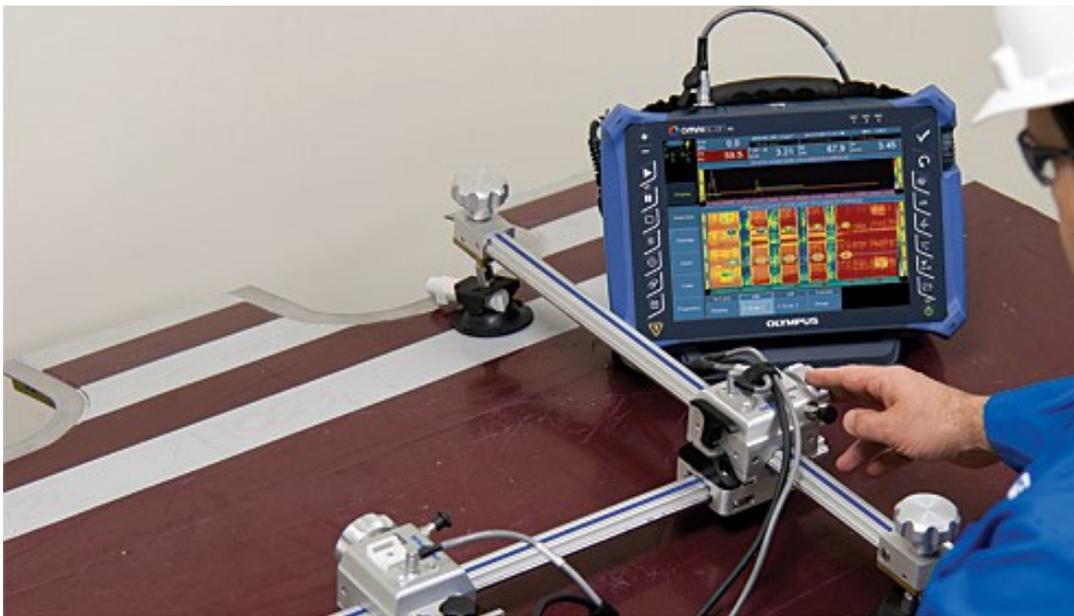
Figure 3: Ultrasound inspection in a composite part, using a field deployable equipment. The technique has been used with composite materials with success, showing potential to work as a tool to monitor composite repairs as well. Source: [21]

Ultrasound (Figure 3) is a widely used NDT technique that uses high-frequency sound waves to detect internal and external defects in pipelines. Ultrasound can detect defects such as cracks, corrosion, and wall thickness variations, as well as being able to determine the size and depth of defects. The technique works by emitting ultrasonic waves from a transducer, which travel through the material and are reflected by the

opposite surface or by a flaw. The reflected waves are then detected by the same or another transducer, and the data is processed to determine the location and severity of the flaw [19].

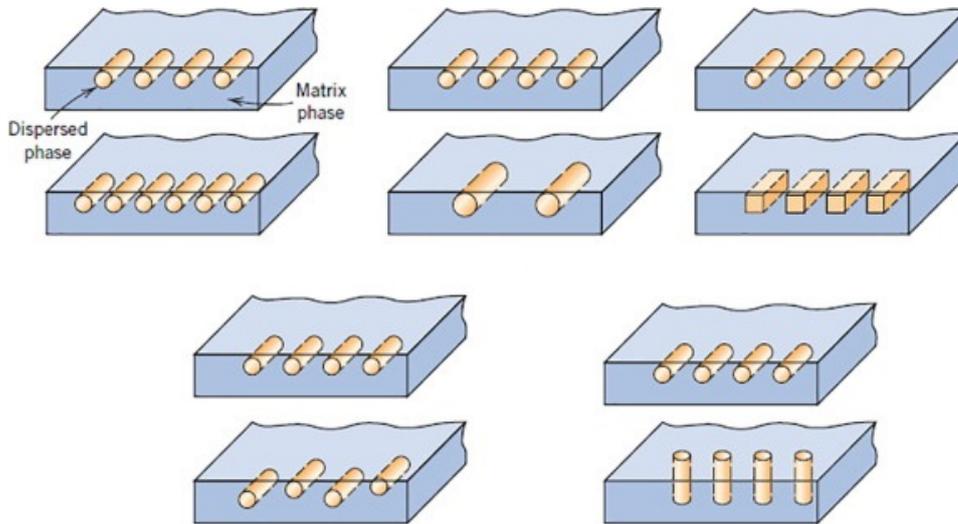
Figure 4: Classic representation of a composite material. Dispersed and matrix phases are represented in different configurations of orientation, distribution and shapes. The dispersed phase arrangement is very important for the final properties of the composite and it is a very important aspect to be considered in the design and/or material selection stages. Adapted from Callister [7].

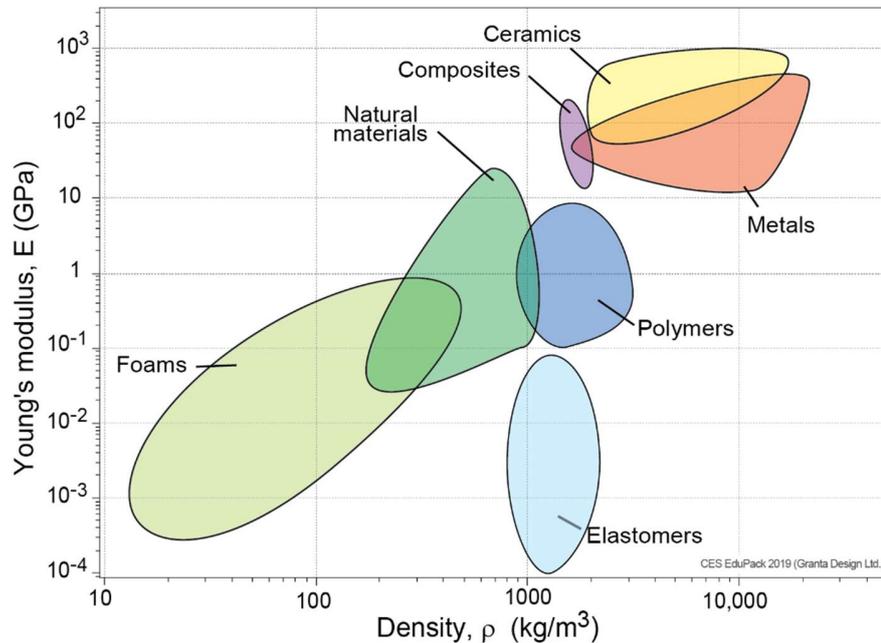
Figure 5: Ashby plot of different families of materials. Composites show comparatively high moduli while having density in the same magnitude as polymers or elastomers. Source: Granta Design (<https://www.grantadesign.com/education/students/charts/>)

Reinforcements can be found mainly in the form of particles or fibers. Particles and fibers differ mainly in their geometry, with particles having roughly the same dimensions in every direction and fibers having a more elongated form factor – usually with a cylindrical shape where the length is longer than the diameter of the fiber. For polymer matrix composites, particles are more often used as fillers to enhance the composite’s stiffness using reinforcements with higher moduli than of the matrix itself. Fiber reinforcements are far more used in higher demanding applications because of the intrinsic characteristics of most high-performance fibers, such as high modulus and/or strength allied with low density and design customization. The combination of polymeric matrices and high-performance fibrous reinforcements creates very desirable properties in what is termed “advanced composites” [8]. Figure 5 shows a

comparison between the specific properties of composites against other families of materials.

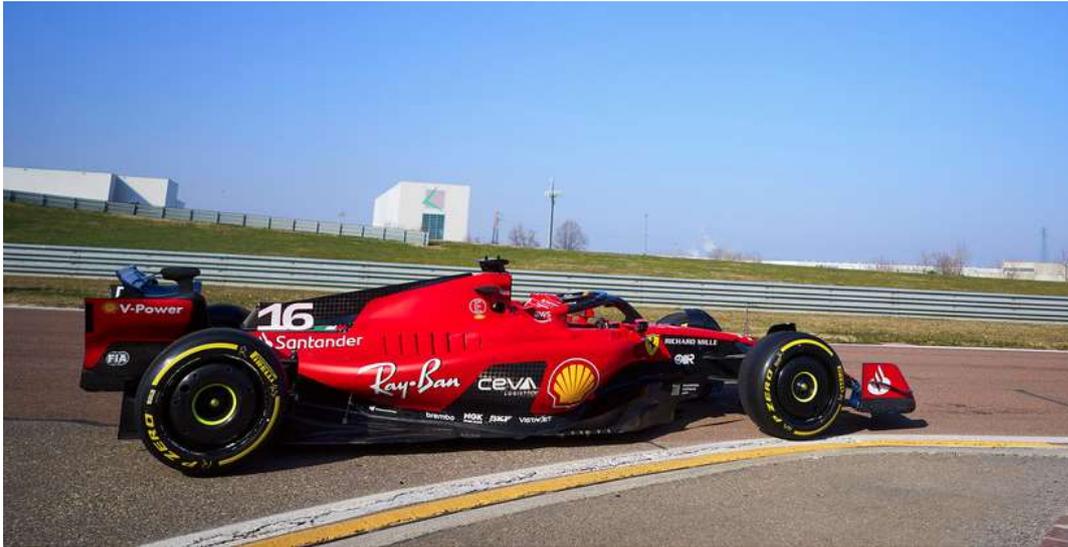
Figure 6: Ferrari SF-23 Formula 1 car. In a modern F1 car, composites are widely used because of its lightweight and high performance. Most of the bodywork, aero, suspension and even parts of the engine are made out of carbon fiber reinforced composites. Furthermore, brake discs use high temperature carbon reinforced ceramic matrix composites that can withstand continuous 1000 °C+ temperatures. Source: Ferrari.com

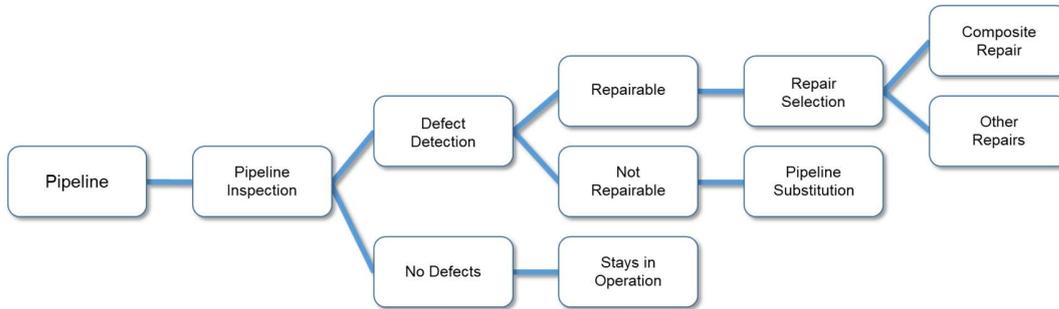
Figure 7: Flowchart of the decision making process involved in repairing a pipeline. After initial inspection, in the case of damage detection, a sequence of decisions must be made.

determined as a function of the risk a defect poses to the pipeline [20]. A chart of the decision-making process is shown in Figure 7.

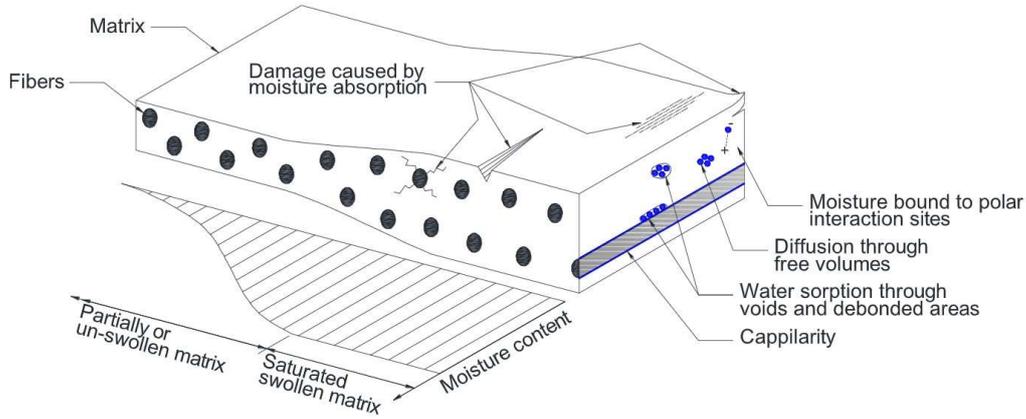
Figure 8: Effects of moisture uptake in a fiber-reinforced composite material, such as a FRP repair - Adapted from Vieira et al [54].

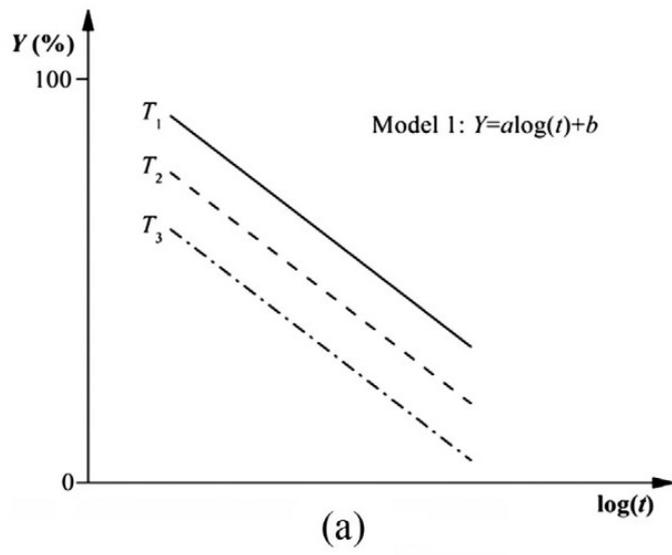
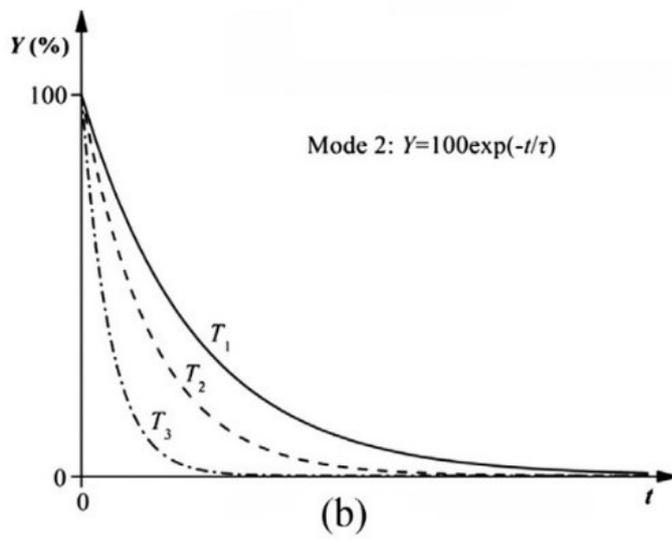
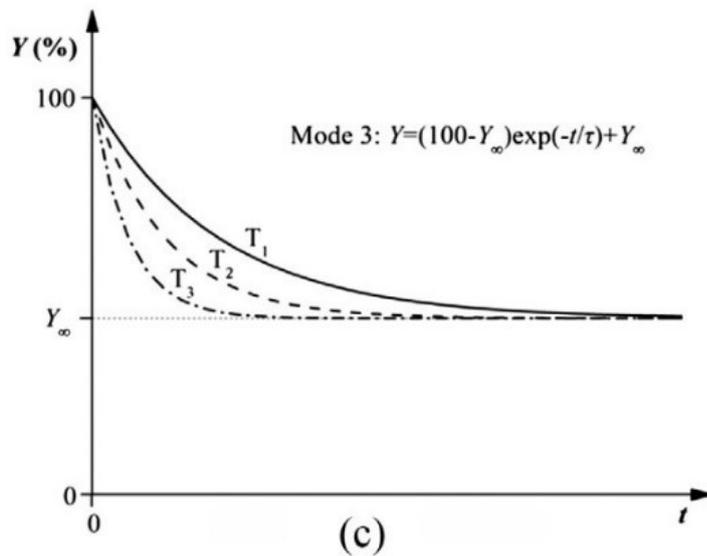
Figure 9: Comparison between three proposed methods by Wang et al. a) Arrhenius-based model; b) Phani-Bose model with property retention reaching zero; Phani-Bose model with property retention reaching a stable threshold at infinity. Source: Wang et al. [78].

Wang et al. [78] compared three different models to evaluate their effectiveness in predicting long-term material behavior (Figure 9). The first one was a simple Arrhenius-like model (Figure 9a), in which the authors confirmed shortcomings previously mentioned by Wu et al. [22]. The remaining two (Figure 9b and 9c) were based on the work of Phani and Bose [24, 25], and proved to correlate much better with experimental data.

The experimental property retention % as a function of ageing time is fitted to a curve using regression and then plotted in an Arrhenius plot. The Arrhenius plot gives the logarithm of the time necessary to reach a certain value of property retain as a function of  $1000/T$  in kelvin. Hence it is possible to predict the amount of time necessary to reach a certain threshold of property retention given a certain temperature or vice-versa. This model has been used with good correlation with experimental data as reported in the literature [22–25, 56, 76–79].

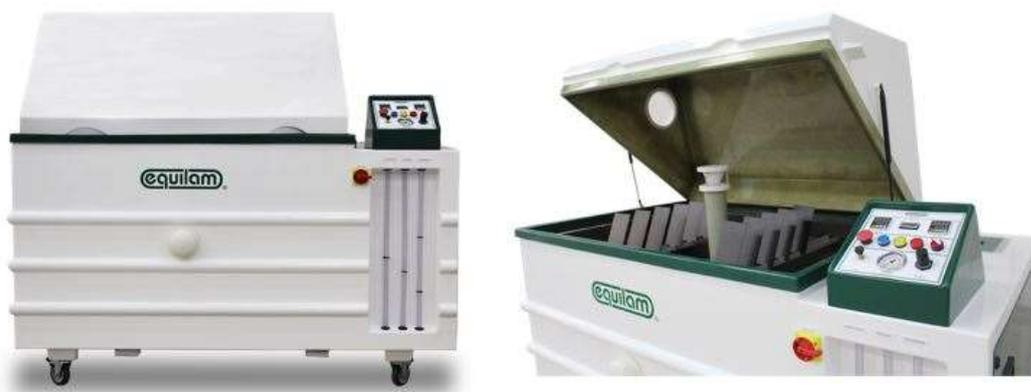
Figure 10: Typical salt-spray test equipment. Source: Equilam

The salt spray mist used in the test is typically a solution of sodium chloride in water, with a concentration of 5% by weight. The samples are placed in a chamber (Figure 10) that is heated to a set temperature (ASTM B-117 specifies 35°C) and maintained at a relative humidity of 95%. The salt spray mist is then continuously sprayed into the interior of the chamber for a specified number of hours, usually ranging from 24 to 1000 hours and beyond [9].

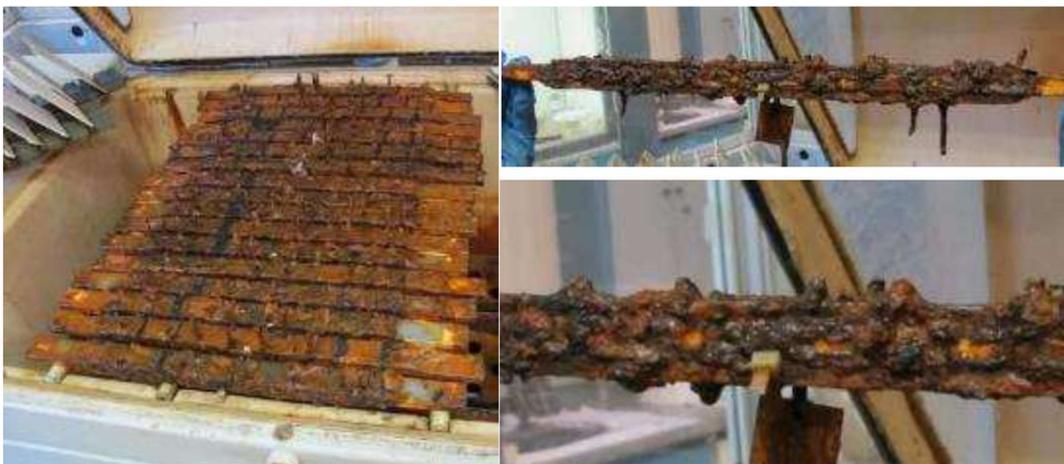
Figure 11: Steel/composite double-lap shear samples after being through salt-spray testing.

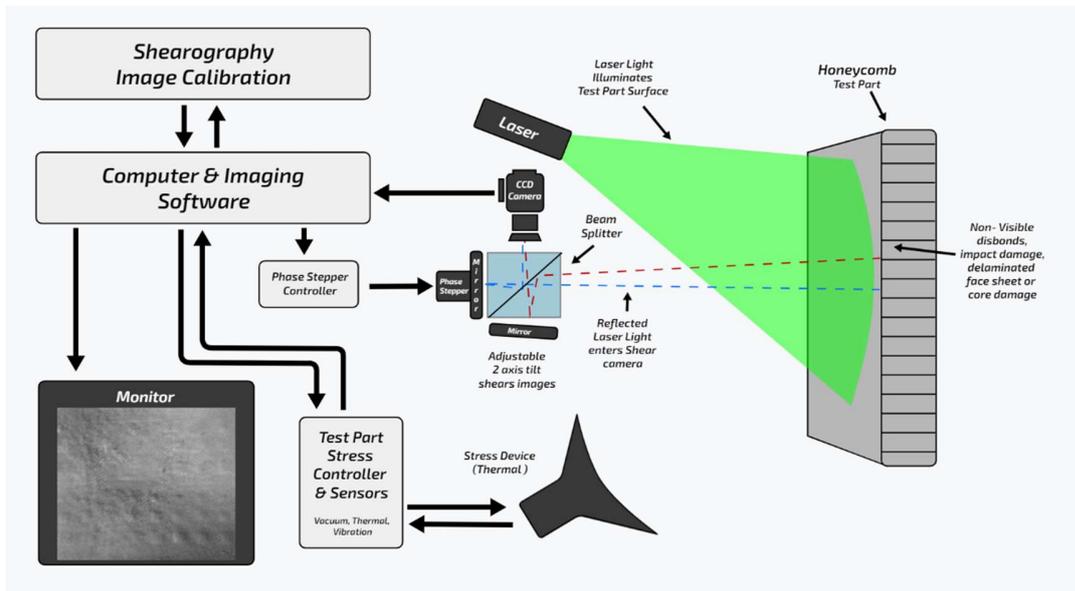
Figure 12: Shearography setup, adapted from [93]. The main components of the setup are the laser source, the modified interferometer, the camera, the computer with dedicated software and a device to stress the sample.

In Figure 12, a typical shearography setup is shown. The setup consists of a LASER source, used to illuminate the sample and generate the speckle pattern, a modified Michelson interferometer with adjustable mirrors to produce laterally dislocated pairs of images, a digital camera to acquire the data and a computer with dedicated software to process and analyze the images. In addition, some form of stress

producing device must be used to cause the necessary deformations in the test object [13].

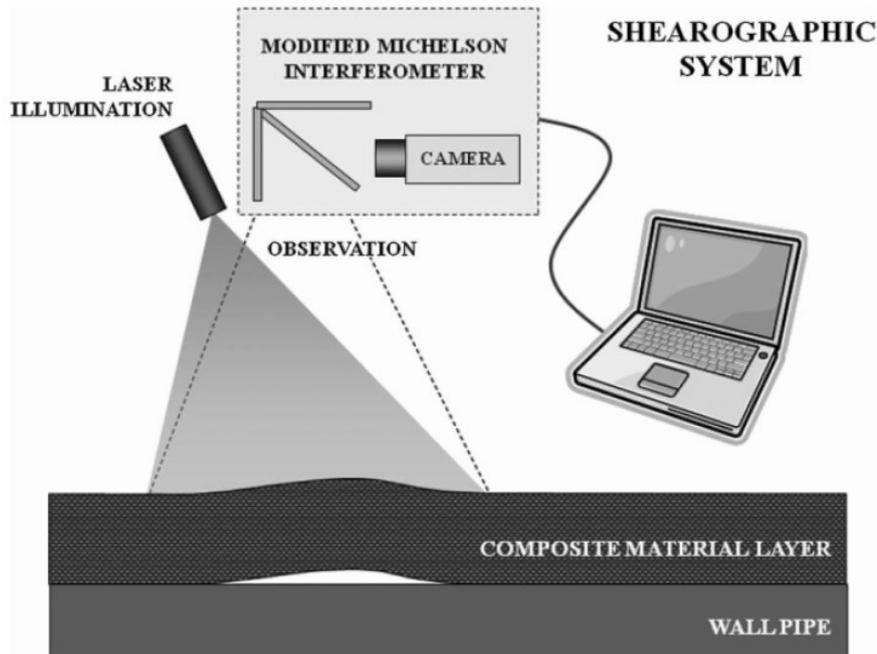
Figure 13: Example of an area of unadhered composite and metallic substrate, a typical use case for shearography inspections [13].

Most defects found in composite materials structures are caused by discontinuities within the material or with the substrate it is adhered to (Figure 13). These can be traced to problems during lamination or throughout the lifetime of the material and manifest themselves as voids, porosity, delaminations and loss of adhesion. These unadhered areas will deform differently from its surroundings once stress is applied, causing discontinuities in the deformation fields, which in turn, will cause anomalies in the interference patterns observed by the operator [20].

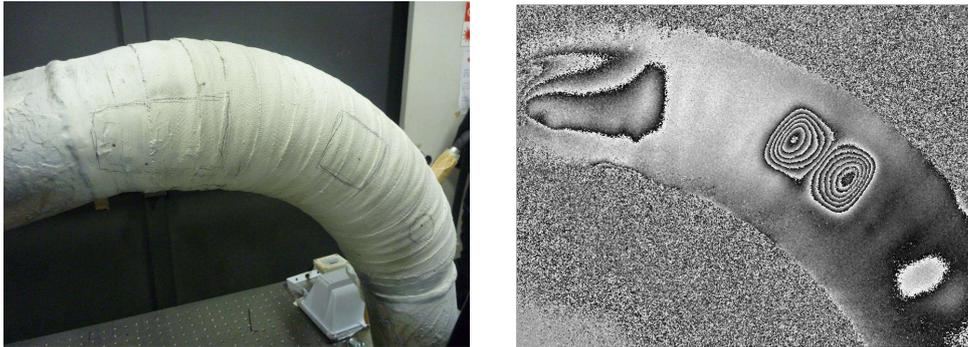
a)

During the inspection, the object is stressed either via thermal, mechanical or vibrational excitation [20]. Most common forms of excitation are thermal and pressure application and only light loads or temperature variation are enough to acquire data – about 4°C or 1 bar. Over-excitation of the test object and excessive vibration during testing can cause problems, since large object movements can make image correlation difficult [13]. Figure 15 shows examples of defects found using shearography inspection in the field.

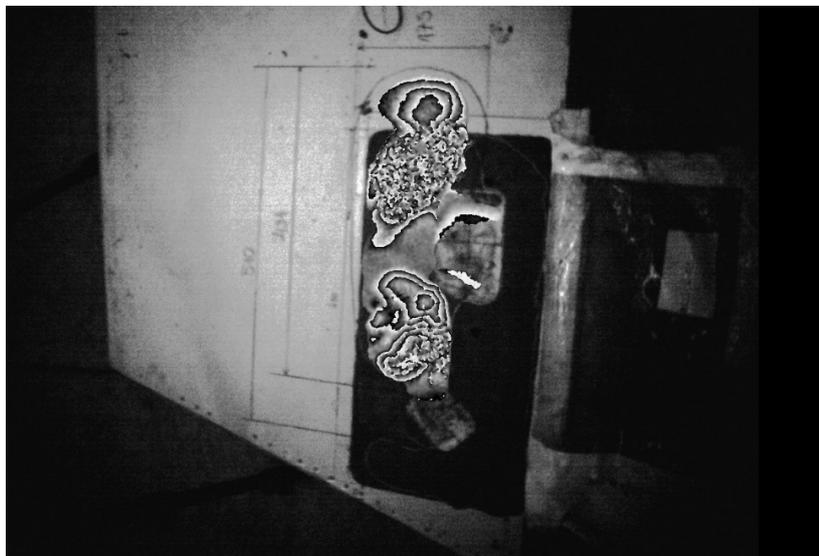
Figure 16: Shearography fringe patterns overlaid on a test subject. The technique detected flaws in a composite elevator flap, from an Airbus A330 aircraft, previously inspected by thermography. Drawn markings indicate thermography detections. Source: Author's own archive.

This technique has been shown to detect some of the most common defects found in composite materials, with applications in a great variety of industries [13, 91, 94–98]. Some examples are tire manufacturers [99], aerospace [18,100,101] (Figure 16) and, more recently, Oil & Gas in such applications like bonded composite pipelines joints [15], composite repairs on metallic pipes [13, 14, 20, 102, 103], pressure vessels [102] and ship hulls [104].

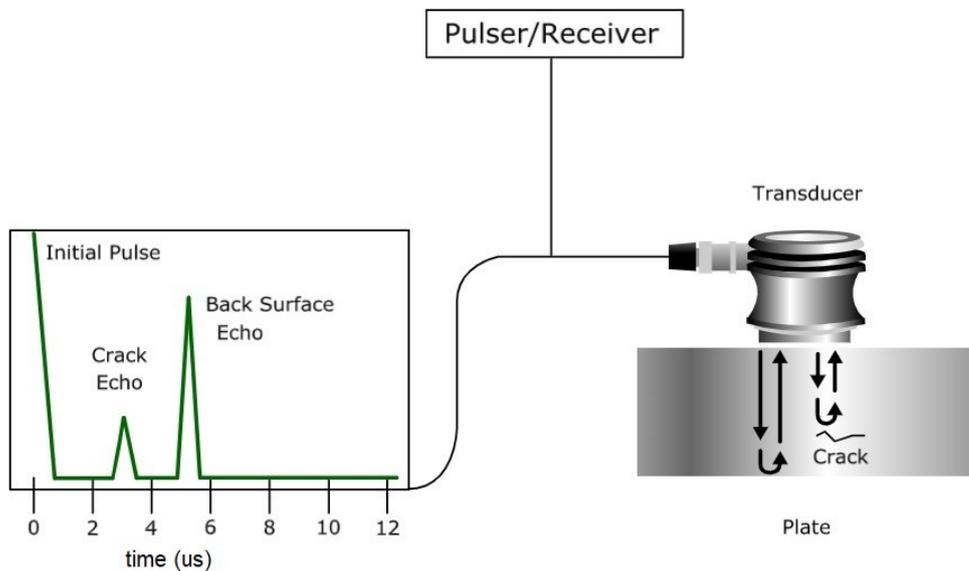
Figure 17: The reflected signal strength is displayed versus the time from signal generation to when an echo was received. Adapted from [19]

One of the most common methods for UT inspections is the pulse-echo technique [17]. In a typical pulse-echo UT setup, the inspection is carried out on only one of the surfaces (contrary to the transmission technique) and the main components are the emitter/receiver, the transducer and a monitor for viewing the signals (Figure 17). The emitter/receiver is an electronic device that can produce high voltage electrical pulses and works together with the transducer. The transducer often uses the piezoelectric principle to convert the electrical pulses into mechanical waves and vice-versa. If there are any anomalies along the path of the wave, a reflection will occur,

which will be detected and converted to an electric signal by the transducer and displayed in a monitor. The information on the monitor is used by the operator to analyze the different reflections detected by the transducer, whether caused by defects in the material (defect echo) or natural reflections caused, for example, by the opposite surface of the material (back surface echo). The time it takes for a wave to travel through the material and be reflected back to the transducer is called time-of-flight and provides important information about the defect detected, such as location, size and orientation, for example [19].

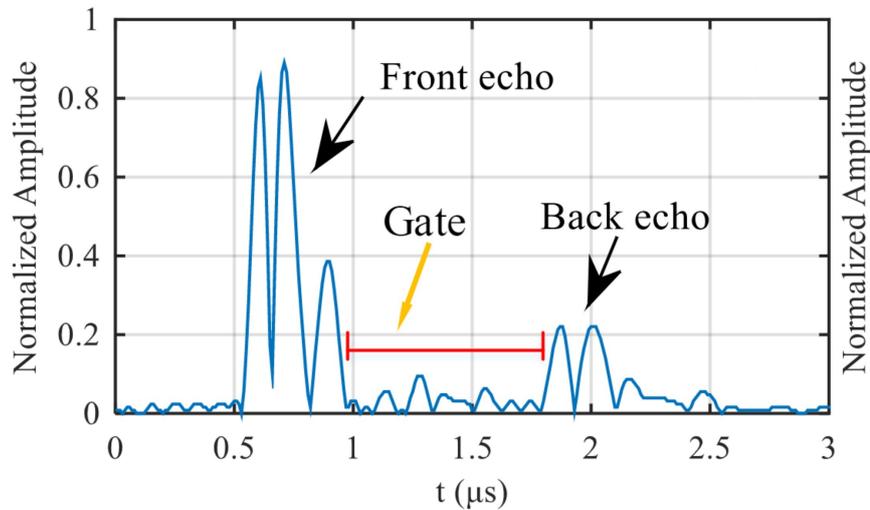
Figure 18: A-Scan signal with a gate set at the red marked region. The gate is set, in this case, between the front and back echoes, which represent the upper and bottom surfaces of the sample, respectively, in order to detect internal damages in the material. Adapted from [111].

The information gathered during the UT inspection comprises a wide variety of signals from different reflections from within the inspected part. Signal processing is an important part of the UT workflow and includes gating procedures (Figure 18), in which a specific reflection (or echo) is separated for further signal processing [109]. Then, automated detection criteria can be applied using algorithms in dedicated software, such as MatLab [110].

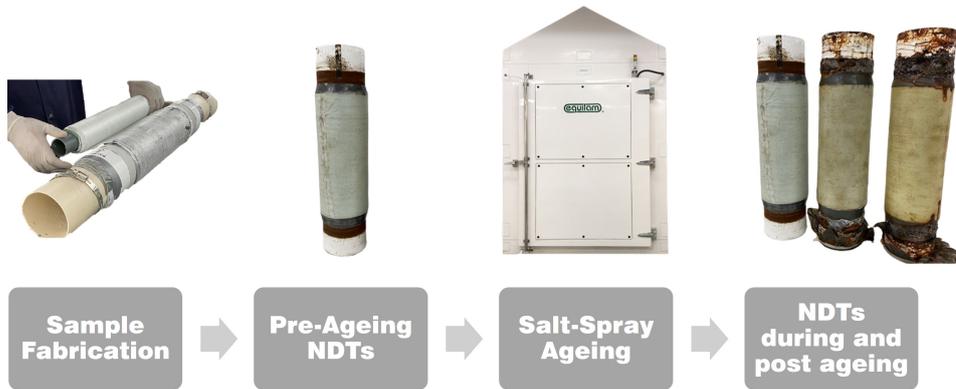
Figure 19: Simplified flowchart of the experimental program.

Samples of steel pipeline with composite repairs were fabricated and analyzed using NDTs both in as fabricated and aged conditions. A simplified flowchart is shown in Figure 19. Repair application was done by one of the manufacturers with the most number of repairs currently in the field, following the specification of those repairs already in operation. Shearography was performed by BAWSF, a service provider already deployed by Petrobras to inspect repairs in the field, whereas ultrasound was performed by LNDC to test their methodology and evaluate the feasibility of use in the real-life scenarios. The ageing process was done in salt-spray chambers custom made for this project, in three different temperatures.

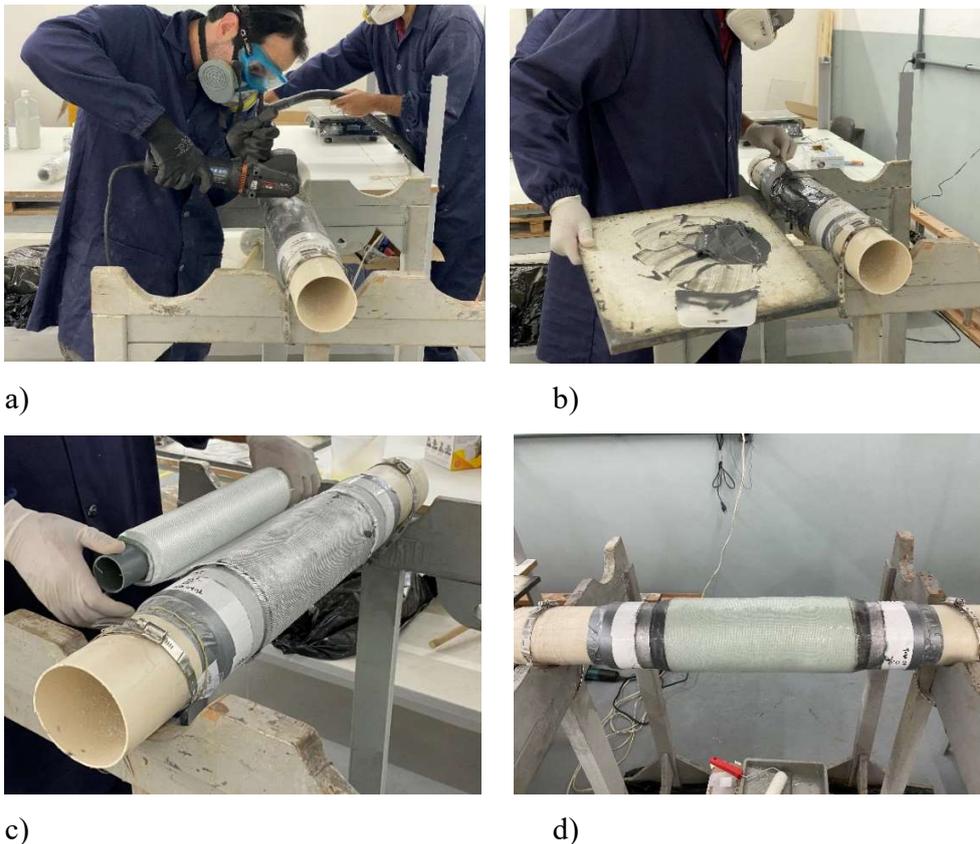
Figure 20: Some of the steps of applying a composite repair to a steel pipe: a) preparing the surface: removing paint and corrosion with a plastic pipe insert used as support; b) applying a discrete adhesive layer; c) applying the wrap; d) finished pipe with repair. Source: author's own archive.

The glass fiber was wrapped around the pipe with epoxy resin being simultaneously applied until the final thickness was achieved. Figure 20 shows some of the steps during the lamination of one of the test samples used in this work.

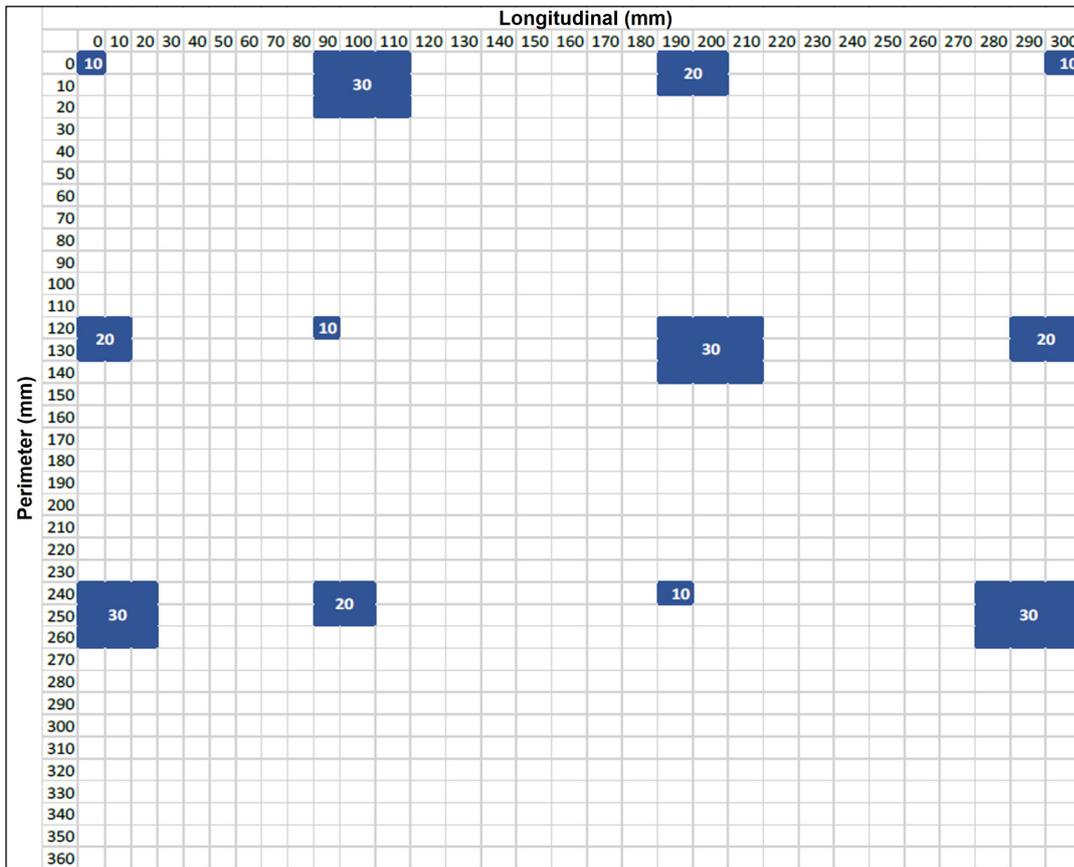
Figure 21: Artificial defect map. The Y axis represents the edges of the repaired area, while the X axis represents the length of the repair.

A reference pipe was fabricated to simulate defects in the interface between pipe and composite repair. The defects were made out of Teflon tape, folded to create

a pocket of air, similar to what would happen in case of localized lack of adhesion. The positioning and size of the artificial defects can be seen in Figure 21.

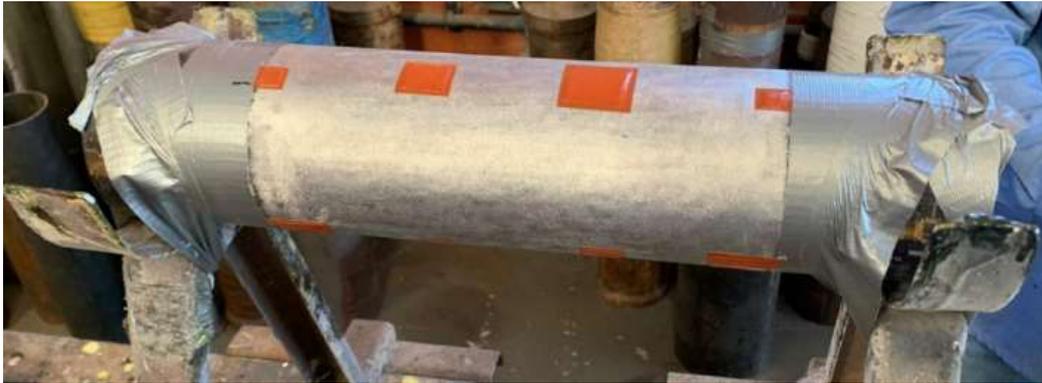
Figure 22: Artificial defects positioned on the surface of the steel pipe, according the artificial defect map.

The artificial defects were positioned directly on the surface of the pipe, before the adhesive layer was applied, as seen in Figure 22. After all the defects were positioned, lamination occurred as all the other pipe samples.

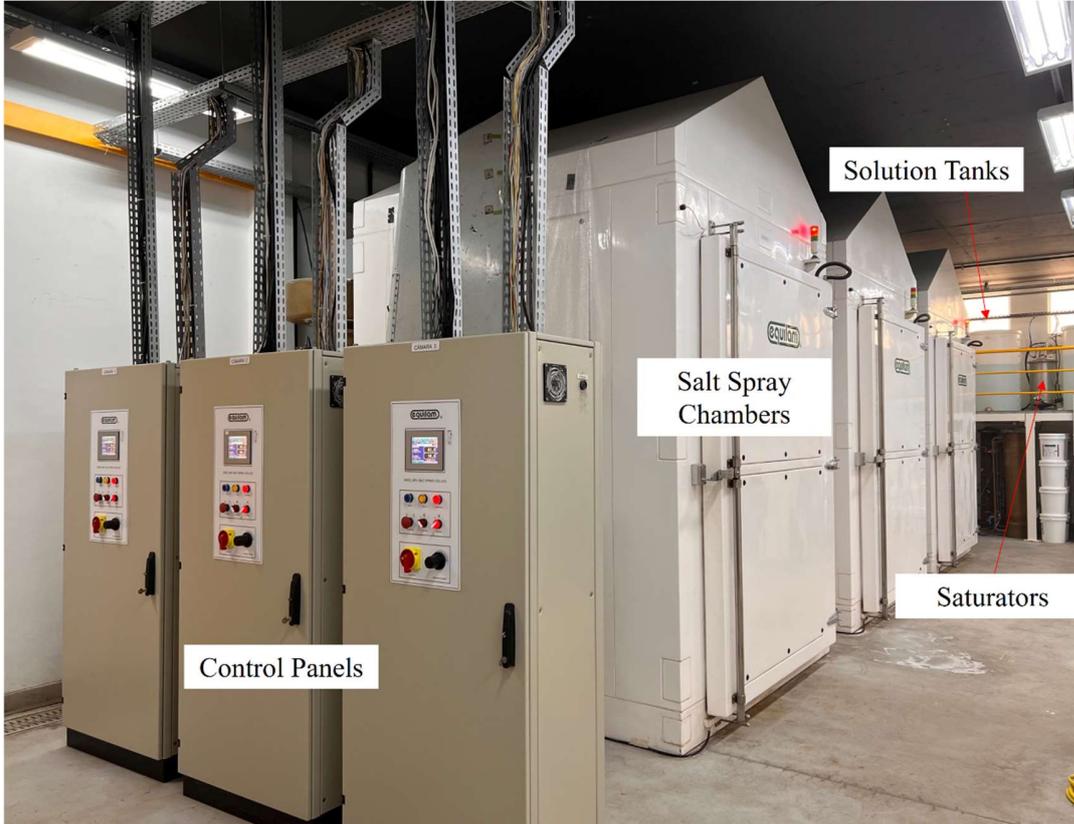
Figure 23: 3 large-scale salt-spray chambers, with the respective control panels in the foreground. In the background, it is possible to observe the solution tanks next to one of the air/water saturators.

Three large scale chambers (Figure 23) were used and each one was set a different temperature. The objective was to evaluate how degradation occurred in different ageing rates and to have enough data to predict life in service of the repair.

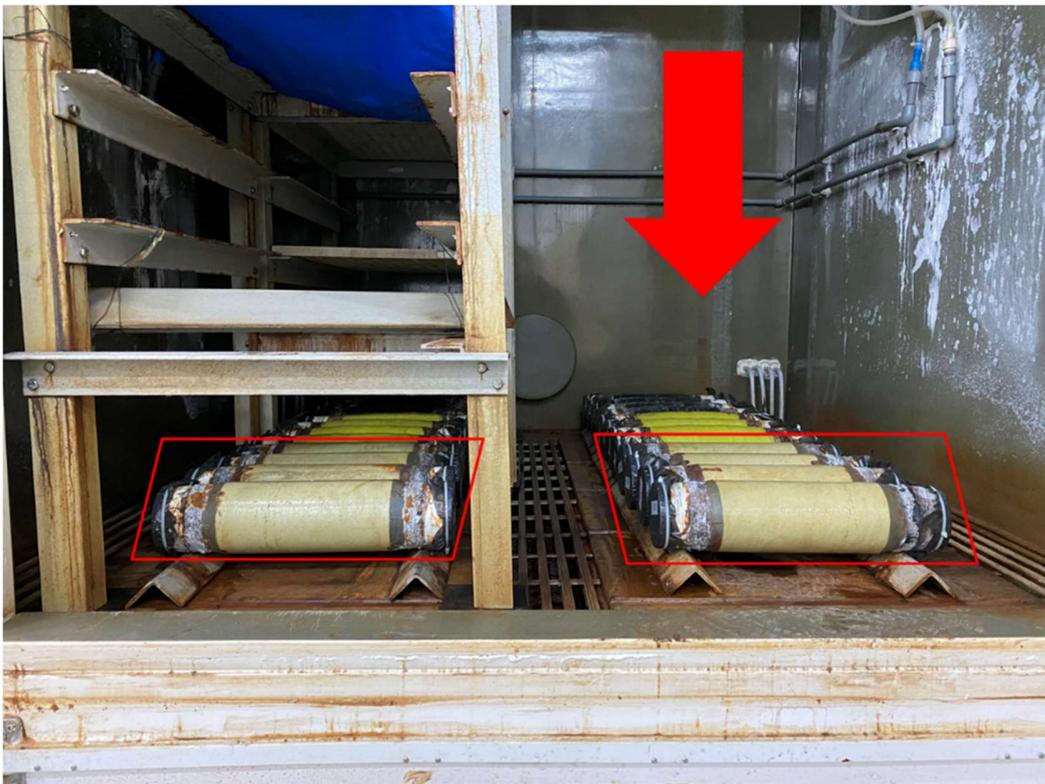
Figure 24: Pipes positioned inside one of the chambers. The samples marked by the red parallelograms are from the same manufacturer and were the ones used for this work. It is also possible to see the black end protection on each one.

In each chamber, 8 pipes were conditioned. The list of where each sample was tested is provided in Table 8. Samples were positioned at the bottom of the chambers, in the same plane, to homogenize the ageing conditions as much as possible. The ends of the pipe were protected and partially sealed to minimize water ingress and internal corrosion. Figure 24 shows the samples positioned inside of the chambers.

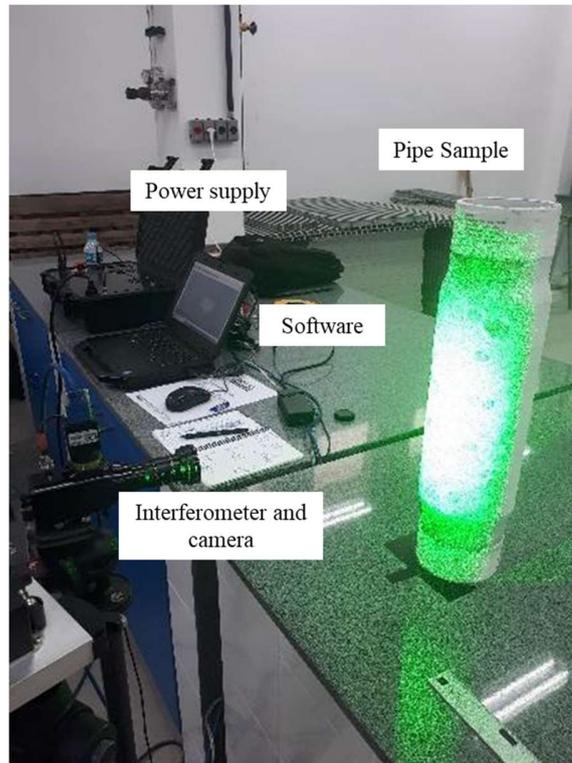
Figure 25: Shearography setup with most of the componentes displayed. Only the LASER source and the lamp used for thermal loading are not shown in this image.

The shearography inspection was performed by BAWSF Inspeções e Engenharia at PUC-Rio’s composite materials laboratory. The inspection procedure was developed by the company’s Level III inspector and the inspections were performed by the Level III inspector and a qualified technician with the setup shown in Figure 25.

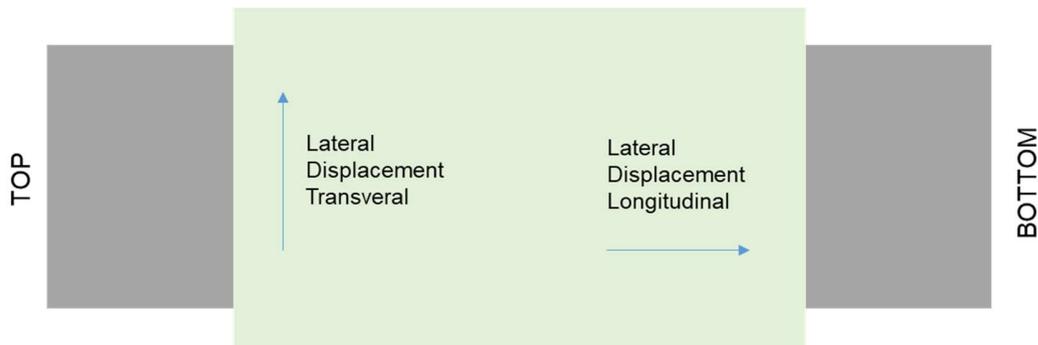
Figure 26: Positioning of the specimen in relation to the originally acquired images and the directions of the lateral displacements used.

Figure 26 shows the positioning of the samples in relation to the original (as acquired) images. The specimens were kept “upright” during the inspections, but the images were obtained “lying down” to optimize the resolution of the interferometer camera. In the reports, images were rotated by 90° (clockwise), representing the actual positioning of the specimens. The lateral displacements were applied longitudinally, from left to right in the image as captured by the interferometer and transversally, from bottom to top in the original image.

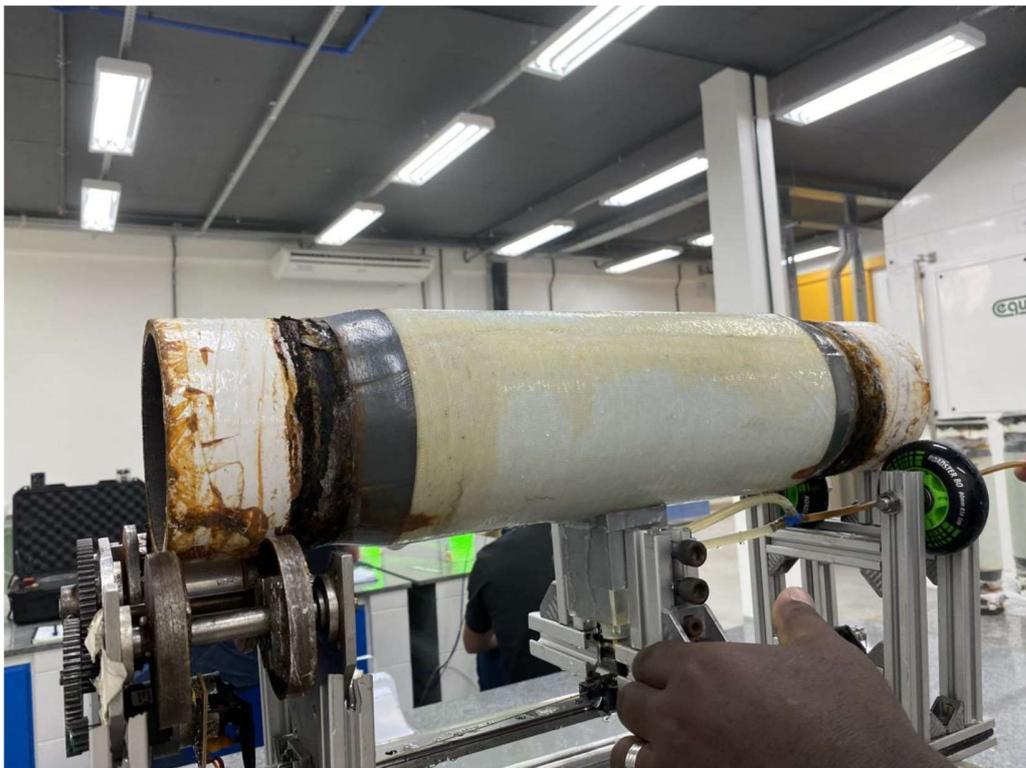
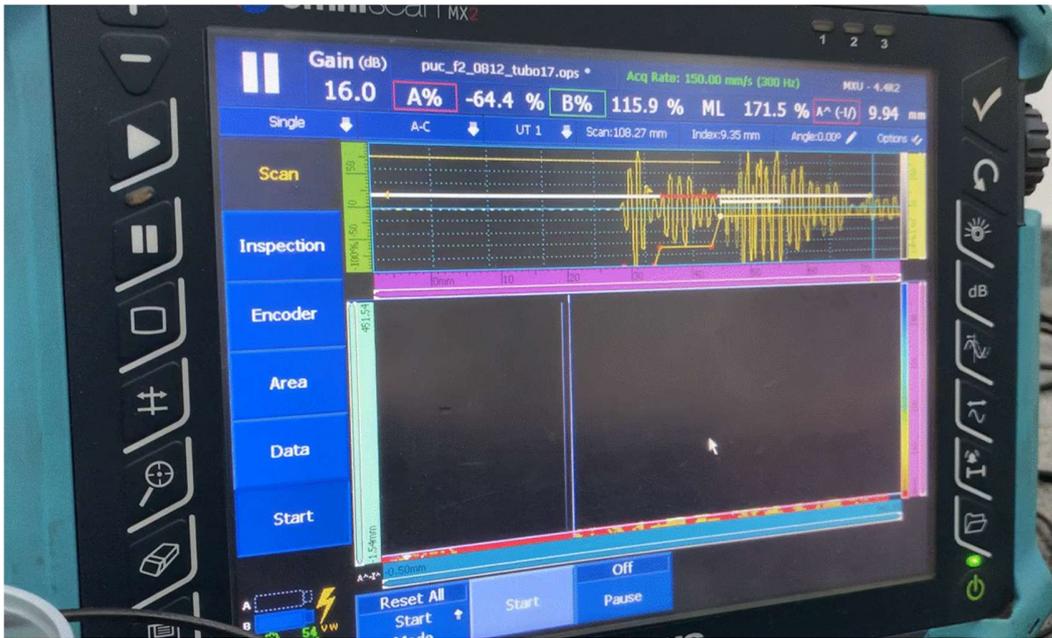
Figure 27: Ultrasound inspection setup: a) Pipe support with water being used as coupling medium being pumped from below; b) Omniscan MX2 data acquisition device.

The ultrasound inspections were performed by the Laboratory of Non-Destructive Testing, Corrosion and Welding (Laboratório de Ensaios Não Destrutivos, Corrosão e Soldagem - LNDC) of COPPE/UFRJ. All inspections were performed by the LNDC's senior researcher and qualified technicians at PUC-Rio's composite materials laboratory using the setup shown in Figure 27.

- Ultrasound equipment: OLYMPUS OMINISCAN MX2;
- Transducer: Olympus C539-SM Normal Incidence and Longitudinal Wave Transducer
- Frequency: 1 MHz;
- Compact water pump to maintain the water flow through the water column;
- Encoders for measuring the transducer displacement in the longitudinal and circumferential axis and of the pipes;
- Matlab software version 2018.

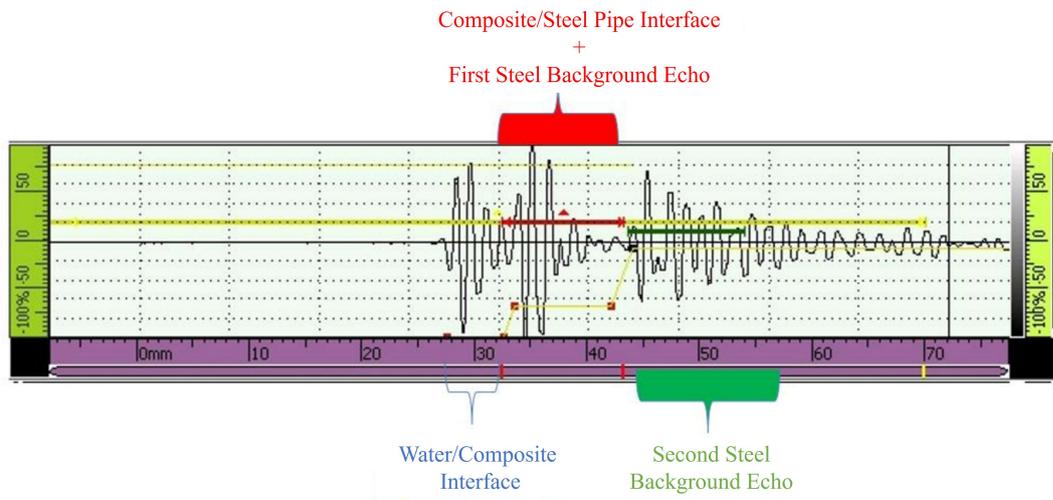
Figure 28: A-Scan obtained from defect free areas of the repair. In yellow, red and green are the gates selected for analysis. In blue is the region of the signal that represents the water/composite interface.

In order to understand the behavior of the ultrasonic signal in the repaired region, points were chosen from the areas of the reference pipe which did not have artificial defects and the A-Scan was analyzed. Figure 28 shows a typical A-Scan obtained from these areas, where it is possible to observe three distinct regions. The first one is related to the echo generated by the interface between the water column and the upper surface of the composite. The second region refers to the echo coming from the interface between composite and steel pipe and first steel background echo. Finally, the third region comprises the second reflection signal from the steel background echo.

Based on these A-scans, as part of the methodology chosen for the inspection, 3 gates were positioned for the analysis of the signal amplitude, based on the regions previously identified. Gate I (yellow): encompasses the entire signal. Gate A (red): covers the range containing the composite/steel pipe interface signal, first background echo and the region where defects signal would appear. Gate B (green): corresponds to the second steel background echo.
