**Comparing Ultrasound and Shearography  
inspections as methods to monitor and predict  
long-term damage propagation of composite  
pipeline repairs**

**Tese de Doutorado**

Thesis presented to the Programa de Pós-graduação em Engenharia de Materiais e de Processos Químicos e Metalúrgicos of PUC-Rio in partial fulfillment of the requirements for the degree of Doutor em Engenharia de Materiais e de Processos Químicos e Metalúrgicos.

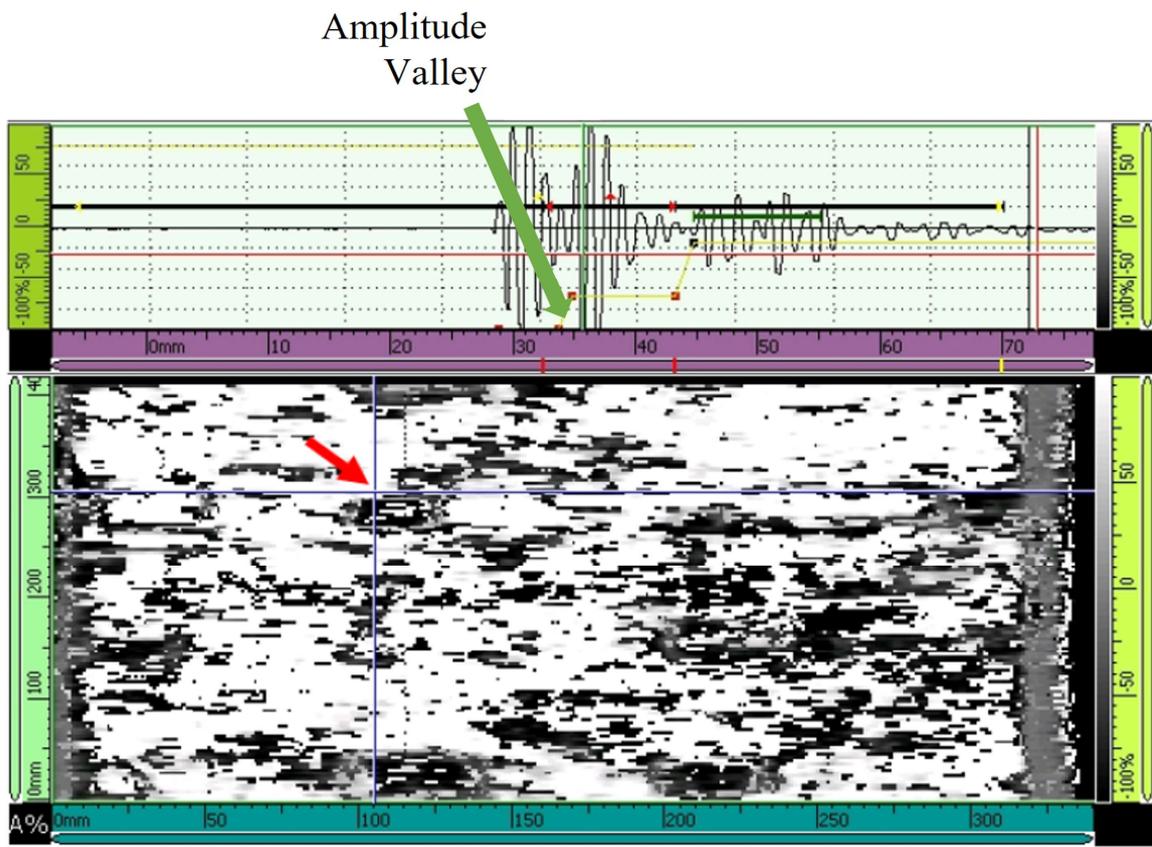
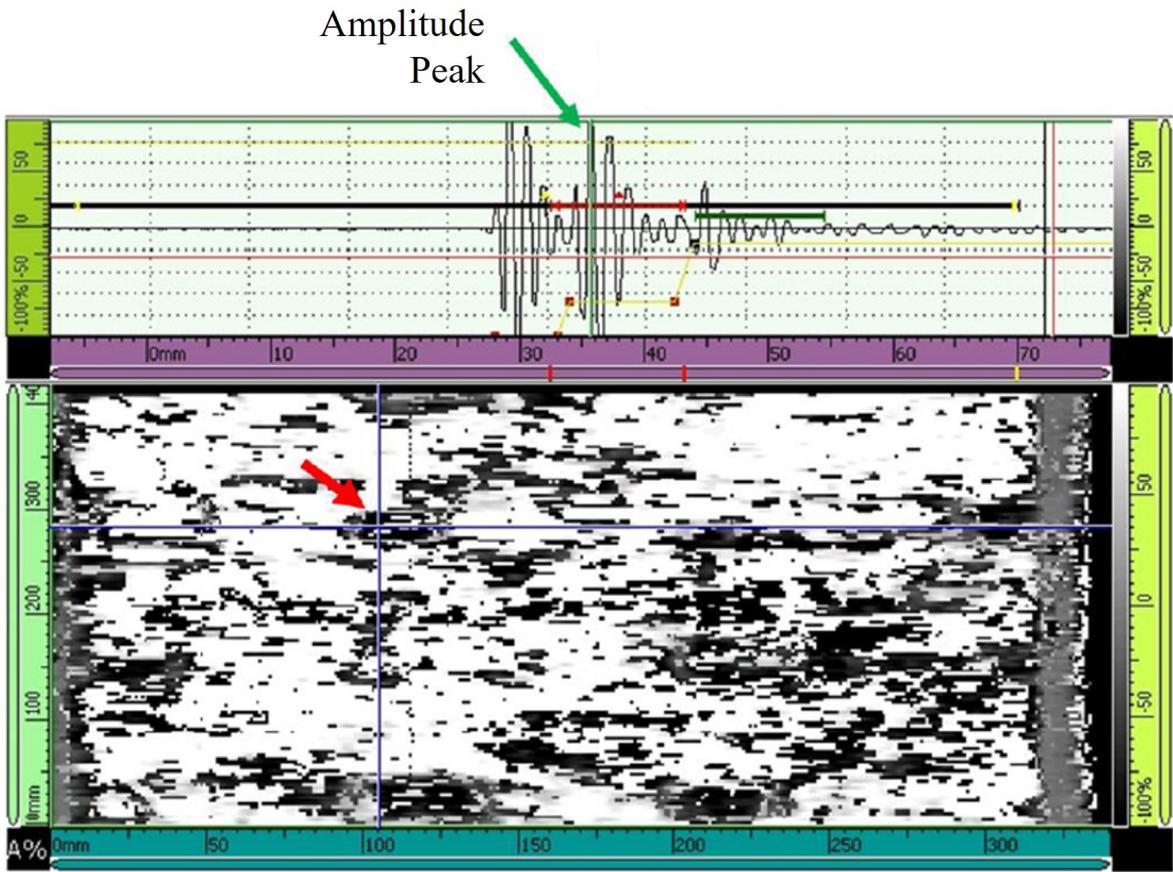
Figure 29: A-Scan representation of the area indicated in red, in the C-Scan: a) Area in the C-Scan showing no defects appears as an amplitude valley in the indicated area of the A-Scan; b) Area in the C-Scan showing defects appears as an amplitude peak in the indicated area of the A-Scan.

At each data point acquired, the A-Scan was analyzed. The phase inversion criterion was applied at Gate A to evaluate whether a defect is present. Although the differences in acoustic impedance and signal characteristics between composite and the steel pipe do not cause significant changes in the amplitude of the signal reflected from the interface, the presence of an air gap can cause such changes. An air gap can be caused by a defect at the interface between the composite and the steel pipe and it would cause the amplitude to change from a valley, where there are no defects, to a peak, where there are defects, according to the preliminary testing carried out by LNDC, as can be seen in Figure 29.

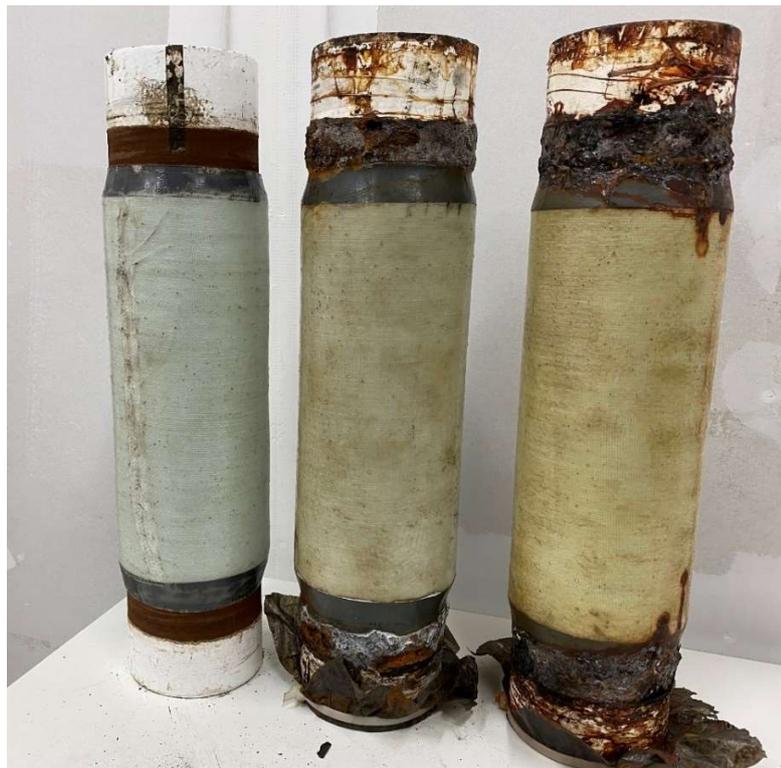
Figure 30: Steel pipes with FRP repairs in different states of degradation after salt-spray ageing: left: unaged pipe; middle: pipe conditioned for approx. 3.400h at 55°C; pipe conditioned for the same amount of time, but at 70°C showing signs of higher degradation.

Throughout the periodic inspections, it was possible to observe how severe the effects of the salt-spray ageing were. Figure 30 shows samples during the T3 (approx. 3,400 h) inspection, in comparison with an unaged sample in the far left. It is possible to observe that corrosion had already spread throughout the entirety of the exposed metal area and was “overflowing” to areas of the edges of the composite and areas of painted pipe. Also of note was the changes in color suffered by the polymeric matrix of the composite repair. The light green hue of the unaged samples turned ever so more yellow as the time of test and harshness of condition (temperature, in this case) increased, with chamber 3 samples showing a stronger yellow tint than all of the others. This color change can be attributed to chemical reactions linked to thermo-oxidation of the epoxy resin [129].

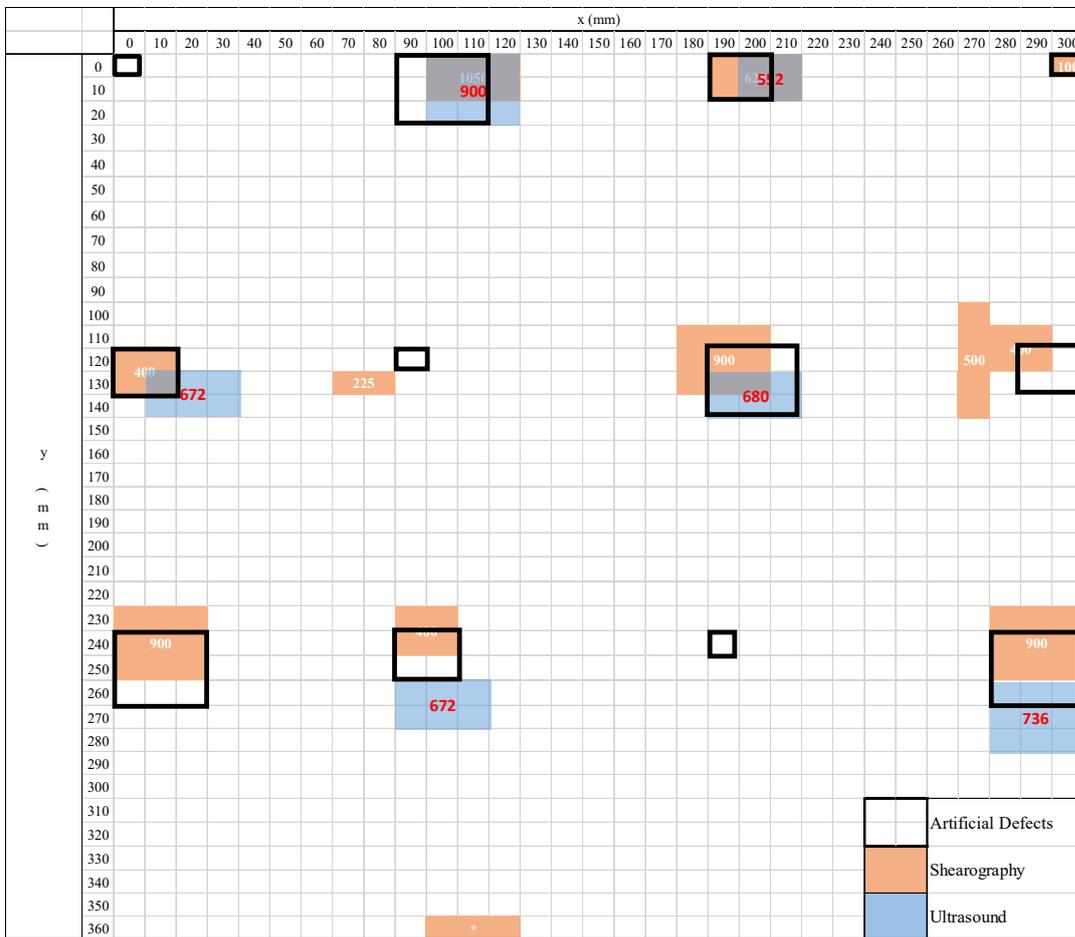
Figure 31: Ultrasound and shearography results overlaid in the artificial defect map. The numbers inside the indications represent the area of each defect in mm<sup>2</sup>.

The results for both ultrasound and shearography are shown in Figure 31. Shearography was able to detect 10 out of 12 artificial defects, while ultrasound detected 6 out of 12. Both techniques showed good accuracy regarding the position of each detected defect. Ultrasound was not able to detect any of the 10 x 10 mm defects while shearography did manage to detect 2, one of them at the edge of the repair. Of the 20 x 20 mm defects, shearography was able to detect all of them, while ultrasound detected 3 out of 4, with the undetected one at the edge of the repair. The same results occurred for the 30 x 30 mm defects, with the undetected defect by the ultrasound on one of the edges of the repair. A summary of the results is shown in Table 10.

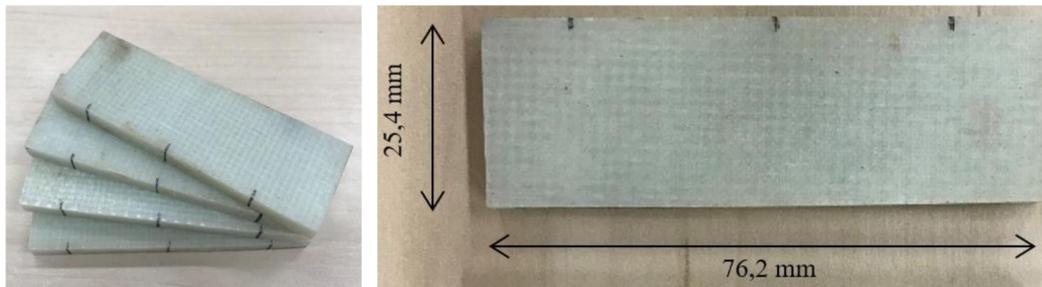
Figure 32: Samples used for water uptake measurements.

From December 2021 to January 2023, 24 samples were inspected by shearography and ultrasound. The time intervals between inspections was of 10 weeks or, approximately 1,670 h. The first two inspections were more closely spaced to account for Fickian absorption occurring in the composite used in the repairs. Composite water uptake was measured according to ASTM D570 and ASTM D5229/5229M [130, 131], using 4 samples (Figure 32) in each chamber which were exposed to the salt spray at the same time as the pipes.

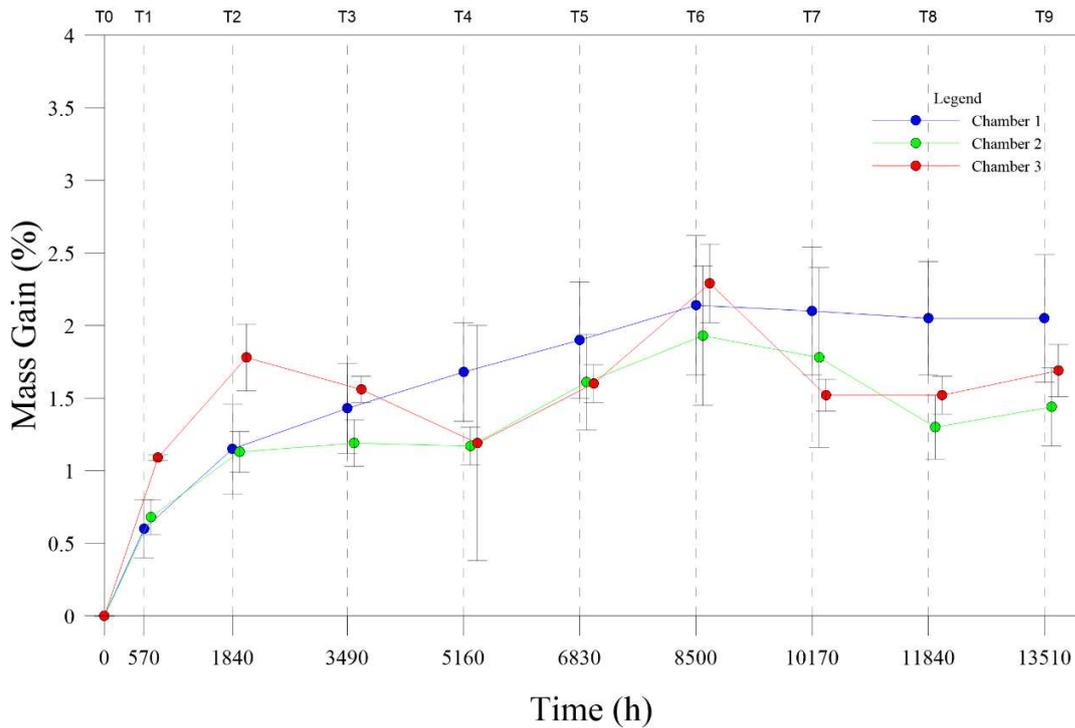
Figure 33: Mass gain % as a function of time. Chambers 2 and 3 reached saturation before chamber 1.

Figure 33 shows the mass gain experienced by the absorption samples as a function of time. All chambers showed a very pronounced initial gain, as predicted by the Fickian model. Samples in chamber 1 (35°C) behaved in a very progressive way, with mass gain tapering off with time up until T7 (approx. 10,000 h) when it seemed to have reached saturation. Samples in chamber 2 (55°C) went into a plateau from T2 to T4, after the initial mass gain. Afterwards, mass gain steadily increased until it peaked around T6 (approx. 8,500 h), after which it suffered mass loss, indicating that saturation was already reached and caused permanent damage. The initial mass gain was significantly more pronounced in chamber 3 (70°C) and was followed by a steady apparent mass loss, probably caused by desorption. After T4, similar to chamber 2, mass gain increased until it reached a peak around T6. Again, similar to chamber 2, mass loss followed indicating that saturation has been reached.

The similar behavior of chambers 2 and 3 could be explained by problems with the equipment used. As the conditions in chamber 3 were very extreme, there were circumstances where testing had to be interrupted momentarily to perform repairs. During these periods, the other two chambers had to be paused as well in order to keep sync between all of the ageing times without compromising NDT schedule. Those periods occurred mainly between T2 and T4, which could explain the unexpected behavior of the samples at this interval. It is likely that the desorption experienced by samples in chamber 3 happened mainly because of high temperature causing evaporation of the moisture when the equipment was paused. Chambers 1 and 2 were less susceptible to this effect because of the lower temperatures, although the plateau behavior displayed by chamber 2 may indicate that some evaporation did occur during this time as well.

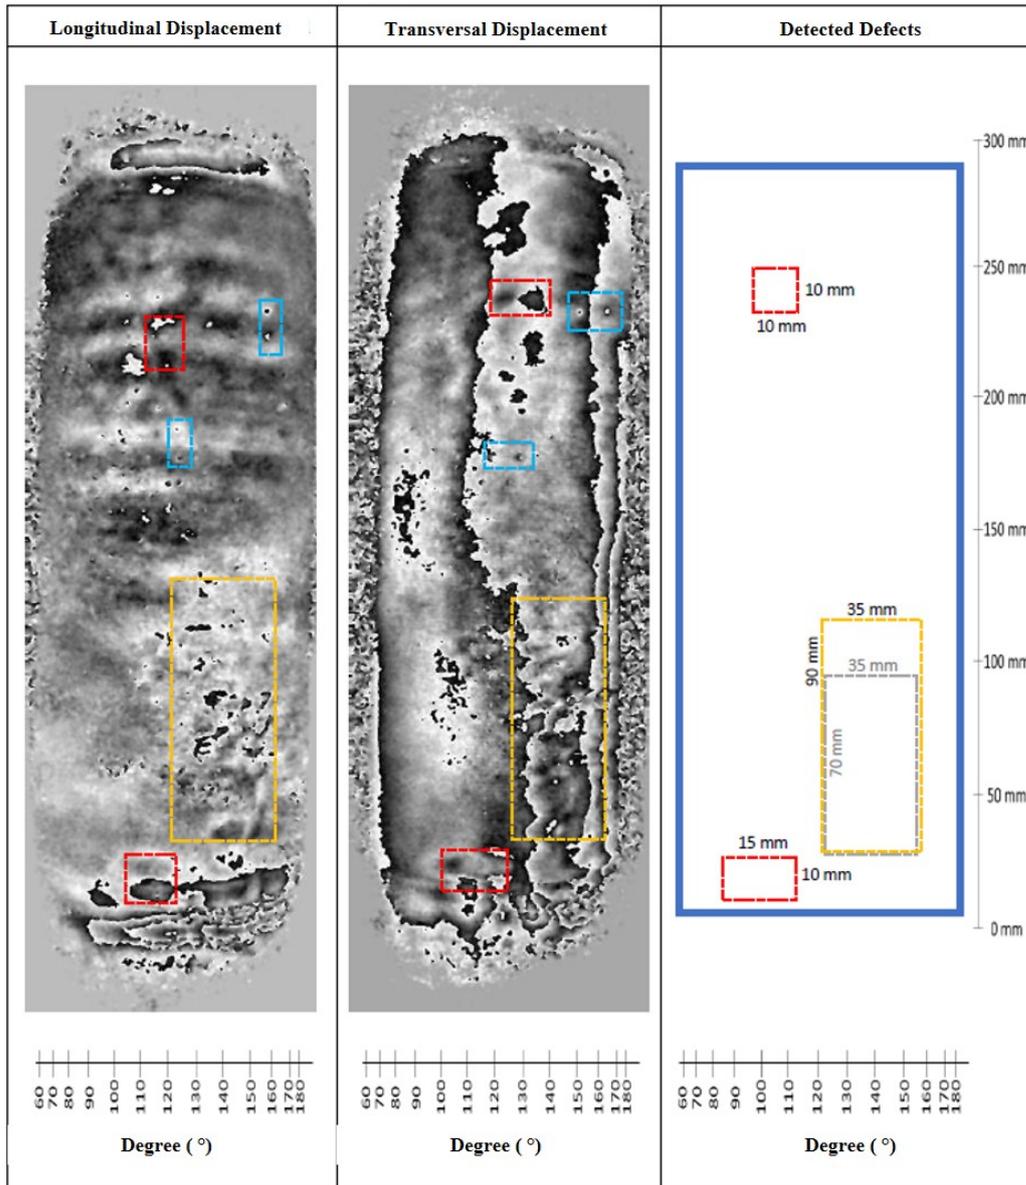
Figure 34: Example of a sample (#2) with the three different defect indications seen in shearography inspection: red markings indicate defective areas; yellow markings indicate potential defective areas; blue markings indicate minor surface defects.

Shearography defect indications were divided into three categories, as seen in Figure 34: defects (red), areas of interest (yellow) and superficial defects (blue). The areas marked in red were what the operator confirmed as defects, by analyzing the fringe pattern movements. The yellow markings were areas that were considered to be potential defects, as the fringe patterns were present but not as well defined as on the areas marked in red. These areas would not be considered defects in a field inspection, so they were not taken into account when measuring defective areas or counting defects. Blue markings were minor surface defects, which do not affect the performance of the repair and were also not taken into account. When there are grey dashed lines inside a red, yellow or blue area, the marked area grew when compared to previous inspections. The grey dashed lines represent the previously detected region, while the colored marking indicates the region detected in the last inspection performed.

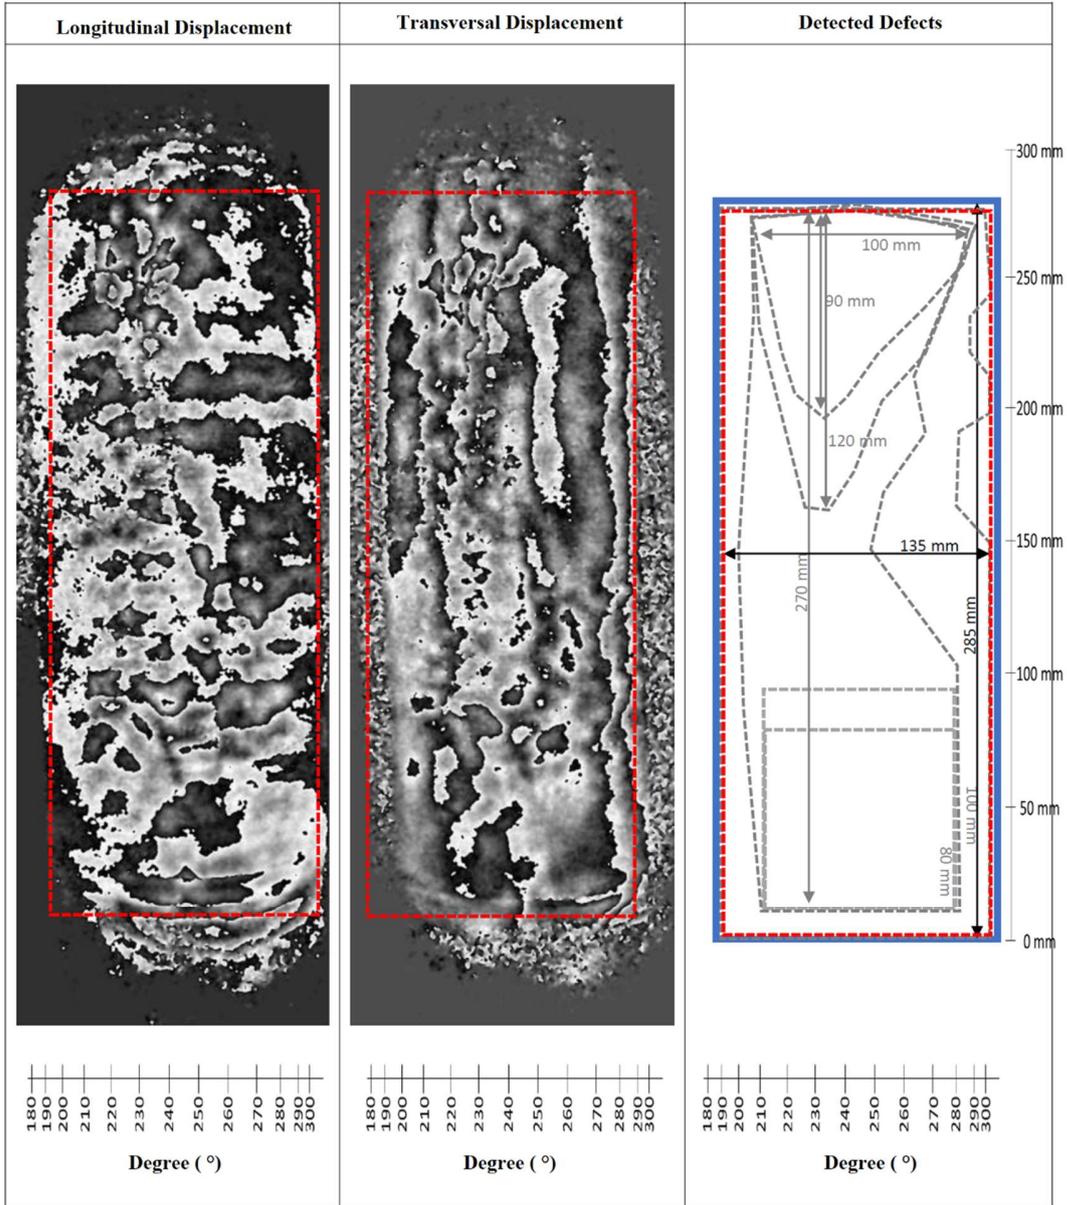
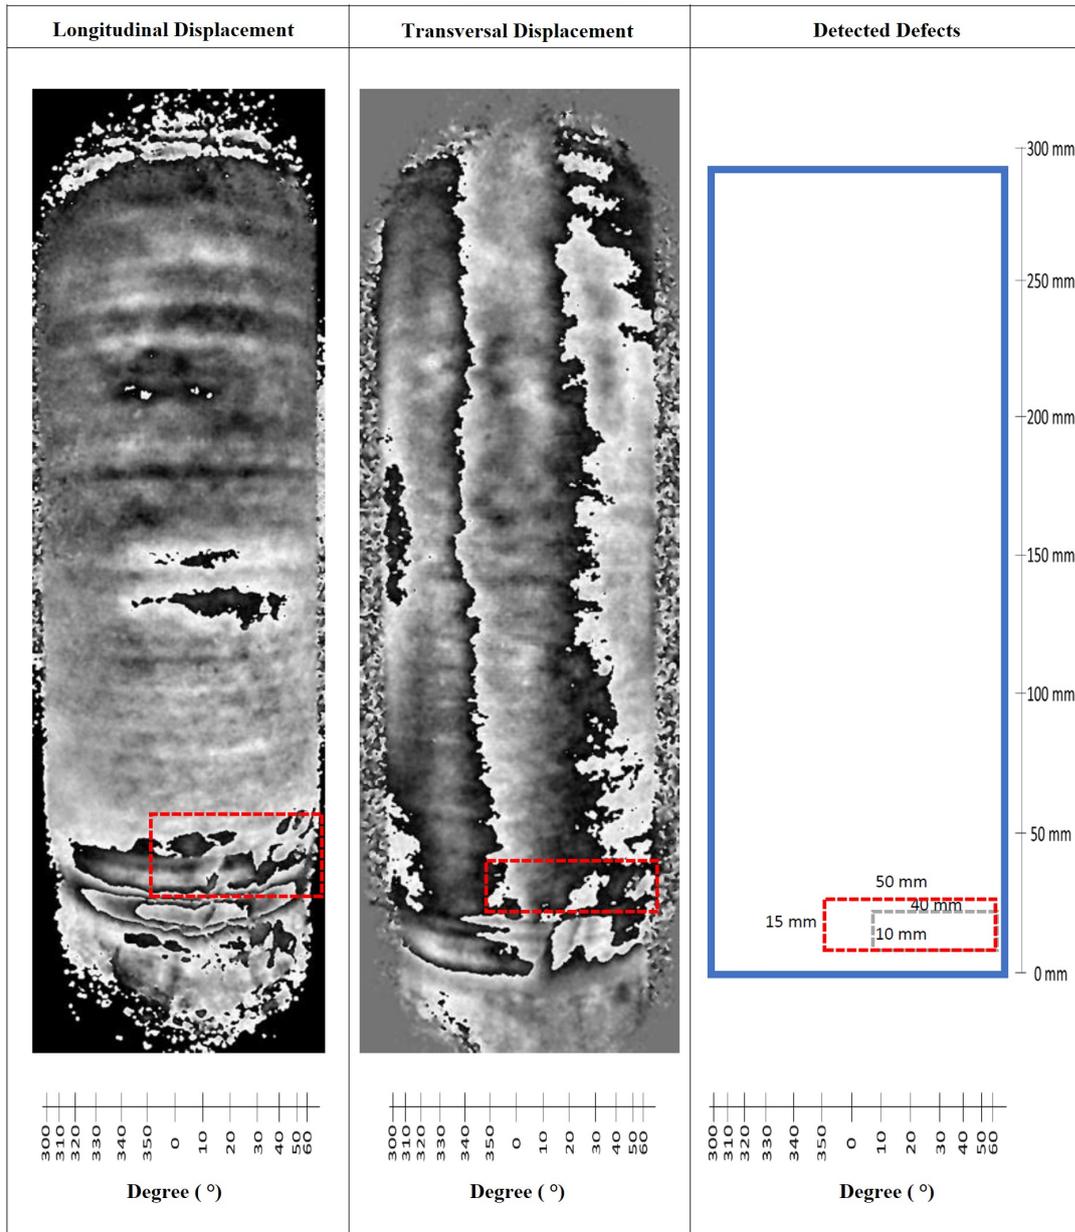
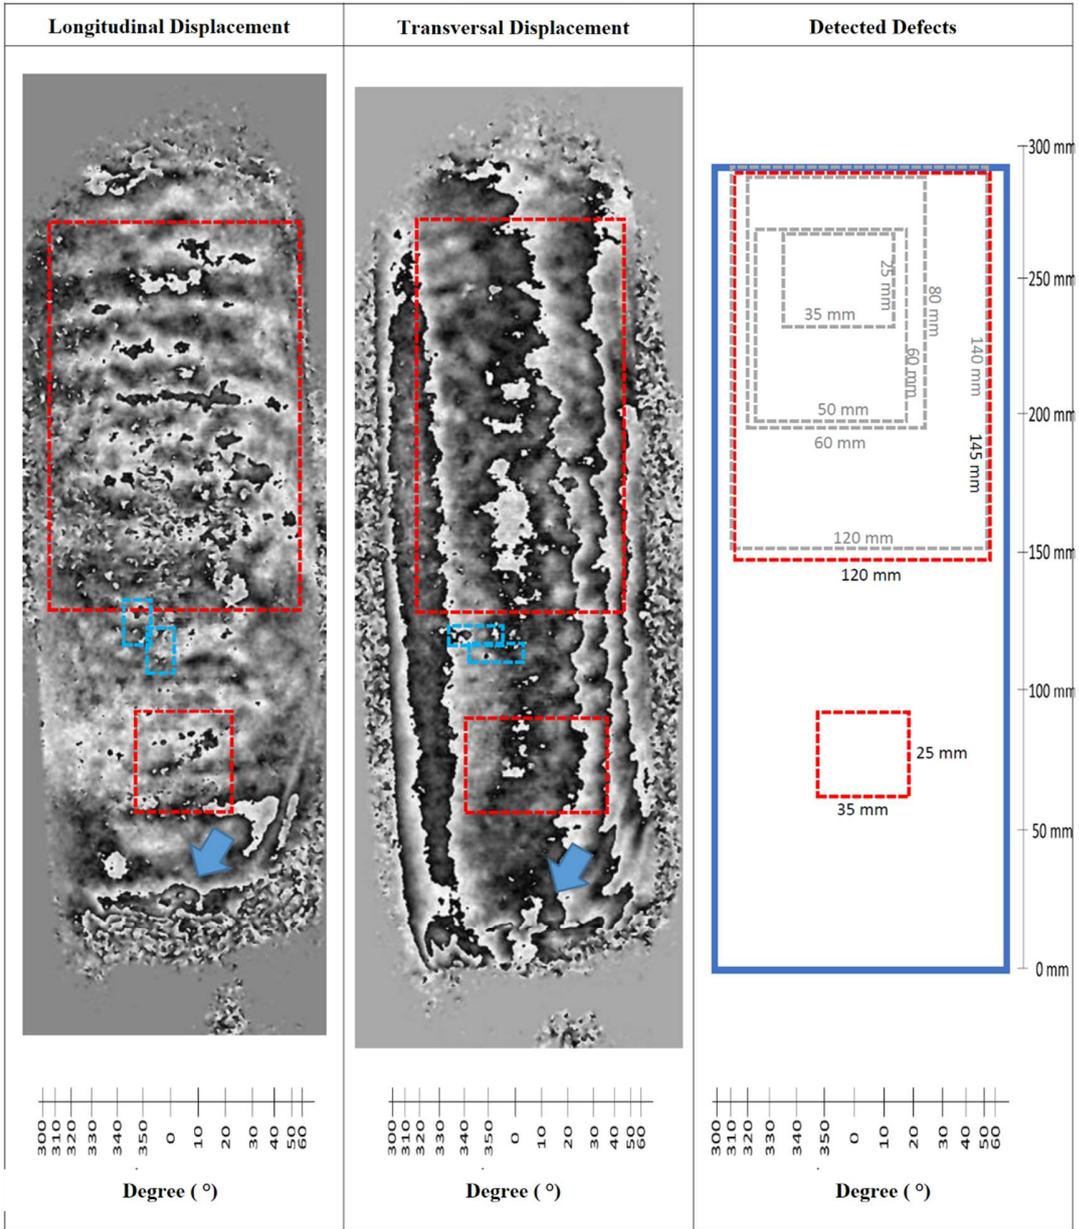
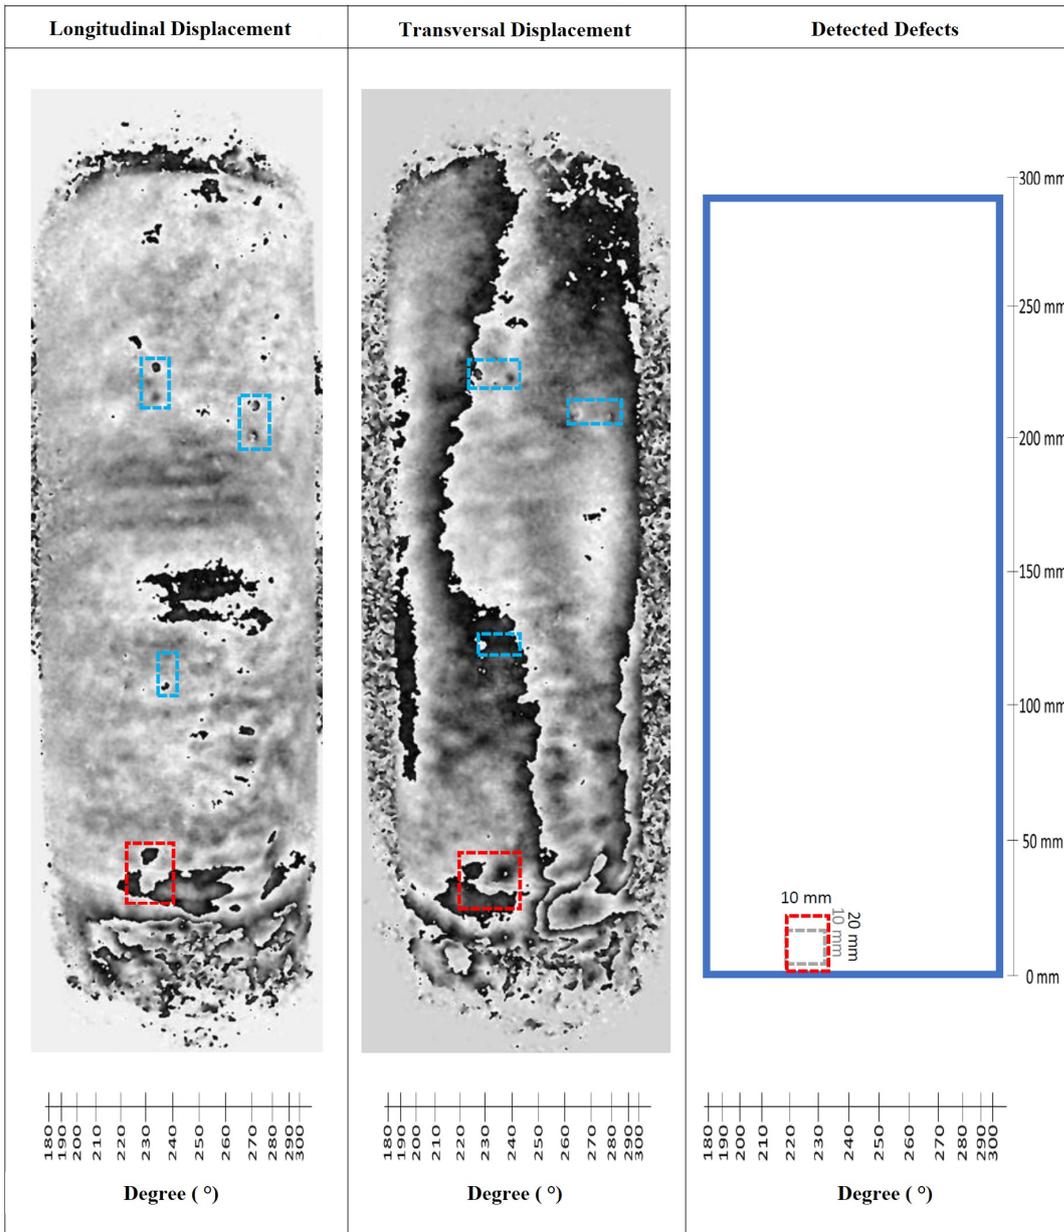
Figure 35: Shearography results showing the evolution of detections through time. Grey dashed lines represent past detections, while red dashed lines represent the last inspection performed. Blue dashed lines are surface defects. (a) Pipe 6, position 240°; (b) Pipe 7, position 0°; (c) Pipe 12, position 0° - blue arrow at the bottom indicates an area of possible defect detections in the future, based on fringe movements; d) Pipe 16, position 240°.

Figure 35 shows the shearography images for the four pipes that showed evolution in detections over time. Each figure is one of three sets of images that compose the whole rotation of the pipe. Images were captured at positions 0°, 120° and 240°, thus, for each sample, that were 6 images, divided in 3 sets of 2 (one with longitudinal and one with transversal displacements). The grey dashed lines and arrows represent the evolution of detections along the inspection intervals and the red dashed line represents the last inspection made on that sample. Blue dashed lines represent

minor surface defects, mainly caused by small resin bubbles gassing out, that were not taken into account.)

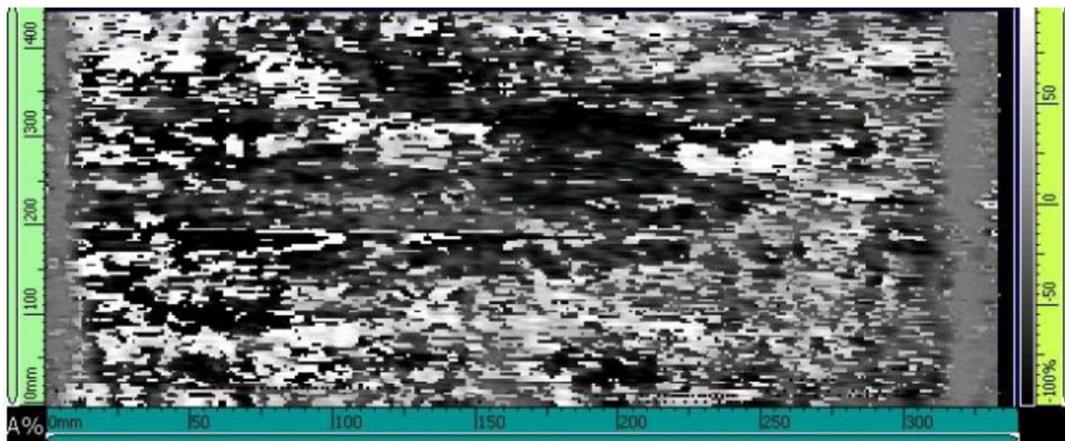
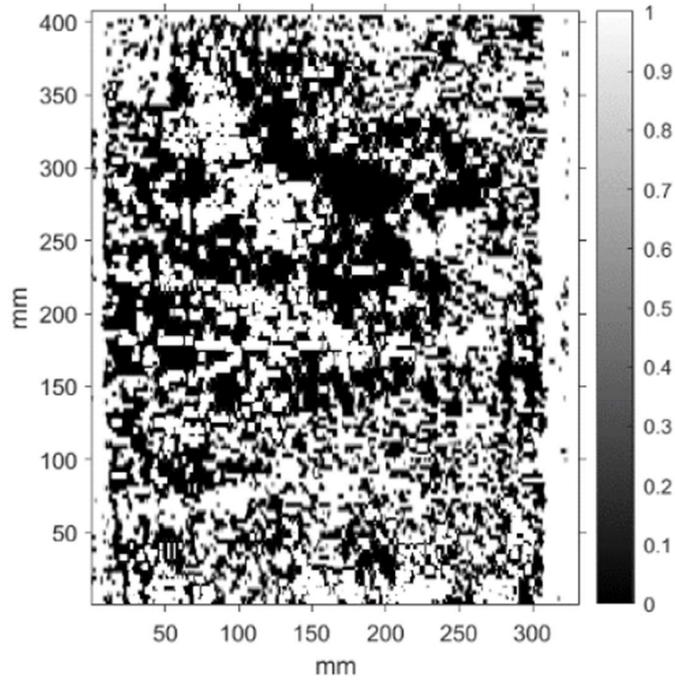
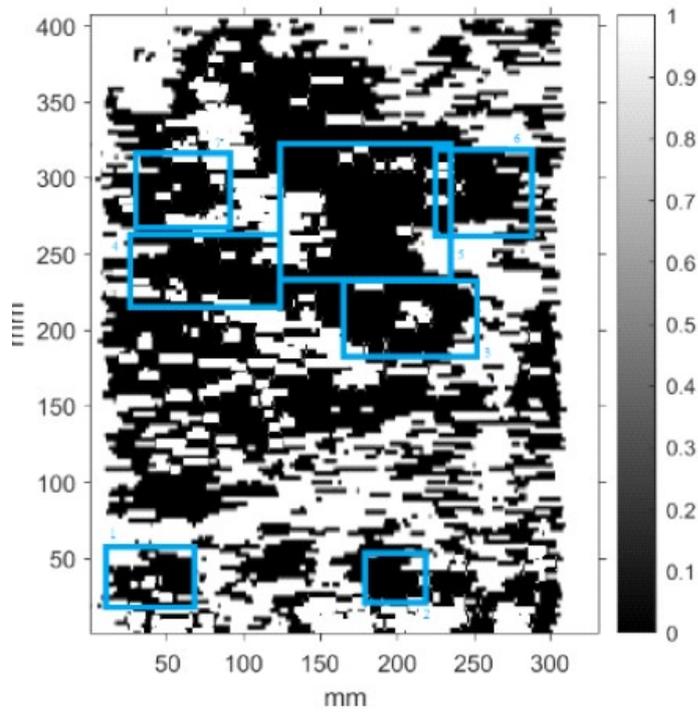
Figure 36: Ultrasound image processing workflow: a) C-Scan straight out of the equipment; b) binarized image; c) binarized image with defect indications.

In Figure 36, the data analysis workflow for the ultrasound inspection is presented. For each specimen, the original C-Scan (Figure 36 a) obtained directly from the Ominiscan equipment without any signal or image processing was presented. For a more detailed analysis of the signal corresponding to the repair regions, Matlab software version 2018 was used with a proprietary routine developed by LNDC. For the analysis routine, it was necessary to insert the images from the C-Scan from the equipment (Figure 36 a), and from the initial analysis in Matlab, proceed with the selection of the signals of interest, binarization (Figure 36 b), and identification of regions with characteristics associated with discontinuities, which are delimited by the blue area (Figure 36 c).

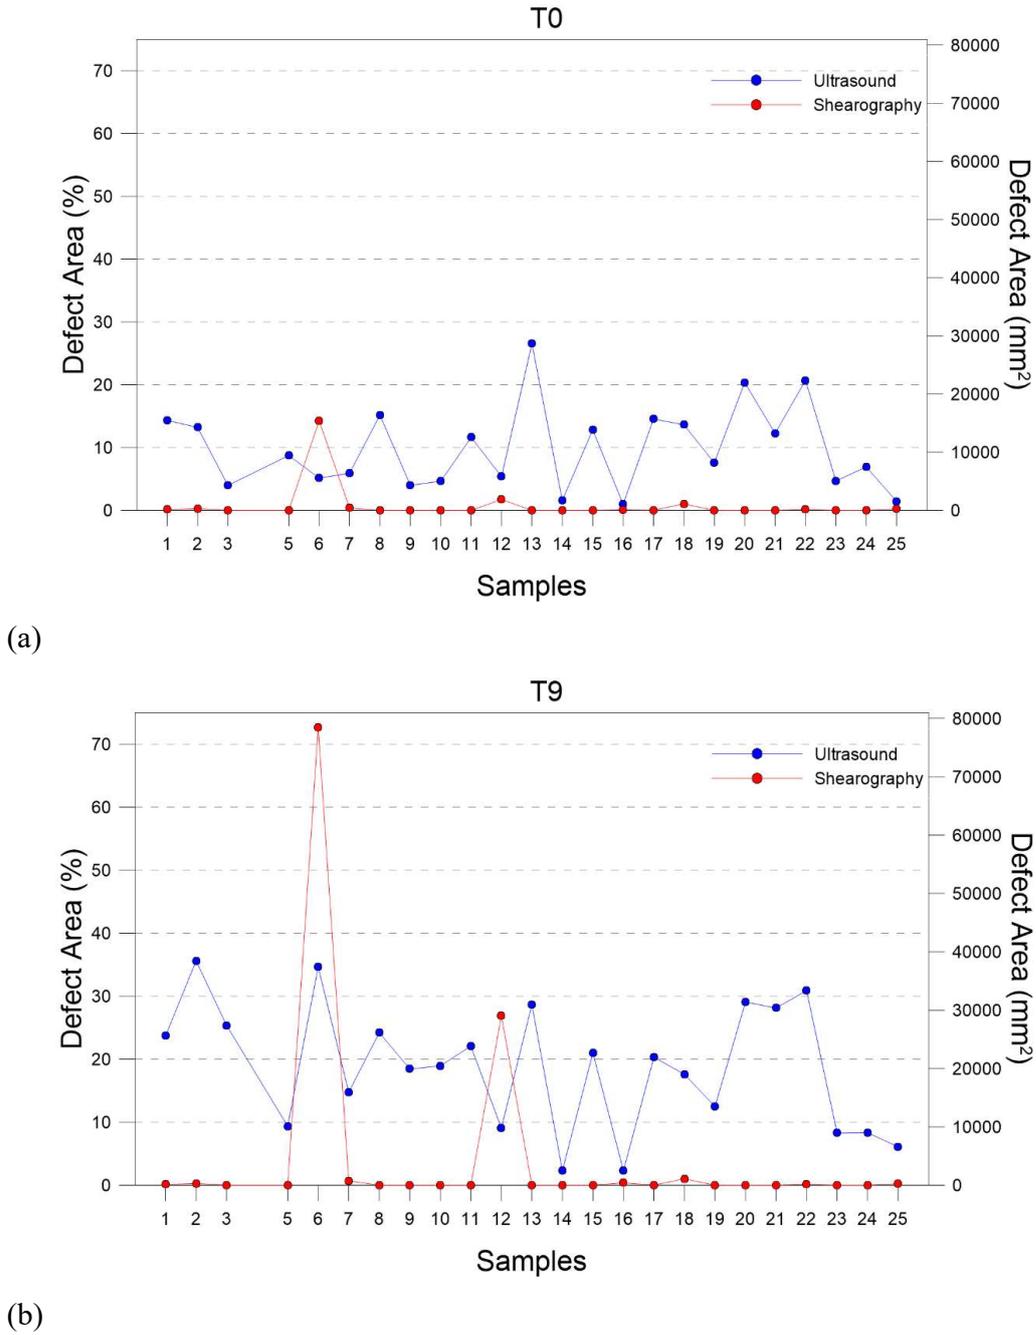
Figure 37: Comparison between UT and SH detections at a) T0; b) T9.

When compared, shearography and ultrasound differed significantly in relation to the detected damaged area. For as-manufactured samples, shearography detected far fewer flaws than ultrasound. Shearography found 10 pipes with indications, only 1 of which had indications larger than 10% of defective area. Ultrasound found that all 24 pipes had some type of indication, with 11 having more than 10% defective area detected. On average, for UT, the defective areas represented 9.83 % of the surface area of the samples, with pipe 13 showing more than 25 % of damaged area. This is a stark contrast when compared to shearography, where average defective area was 0.76 % and the pipe with the largest defective area detected was #6 with 14.26% at T0. The sample with the largest area detected for UT, #13, did not show indications during SH inspection and the sample with the largest area detected for SH, pipe #6, had 5% of its area initially considered defective by UT.

After ageing, the average damaged area increased to 18.97% for UT and 4.31% for SH, while pipes #2 and #6, from chambers 1 (35 °C) and 3 (70 °C), respectively, had the largest area detected with about 35% each for UT and pipe #6 remained the most defective sample for SH, with 72.64% of damaged area. A comparison of detections for both T0 and T9 is shown in Figure 37. Compared to SH, UT appeared to overestimate the area, and the number of defects present in the samples both before and during ageing.

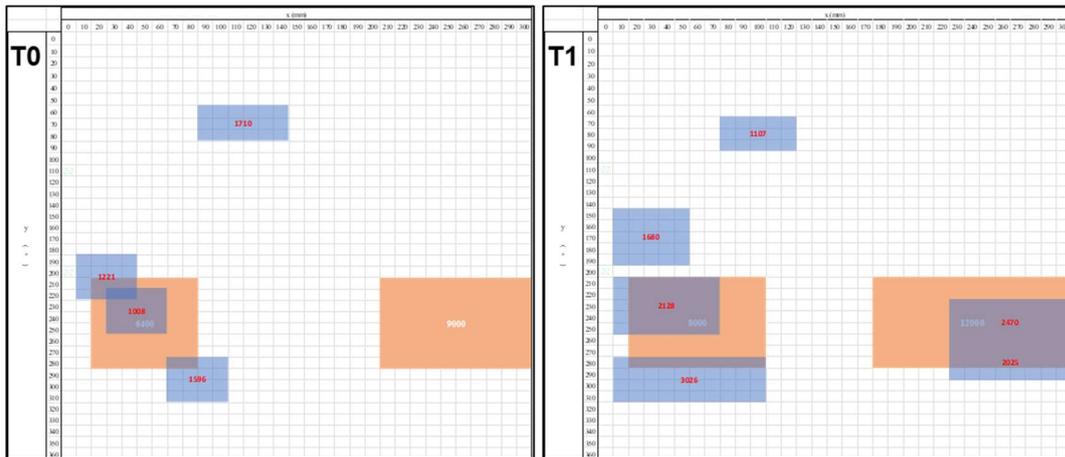
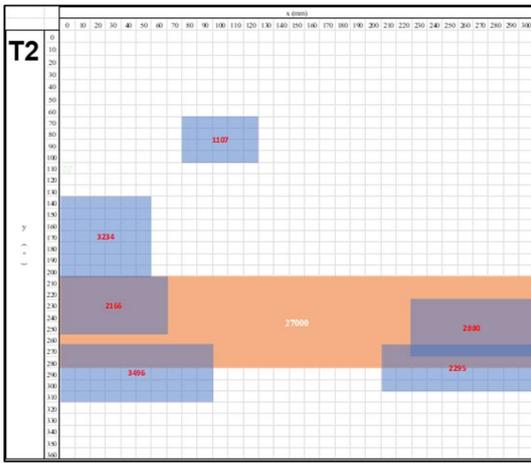
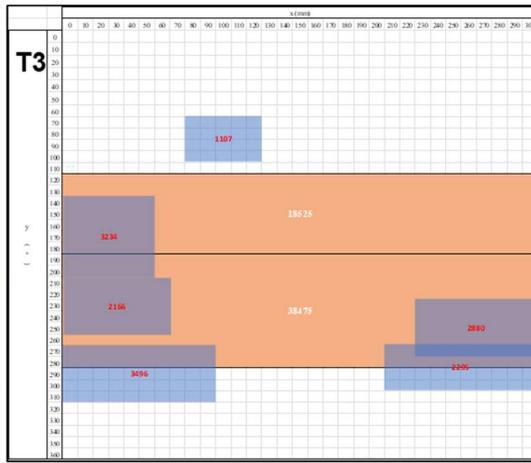
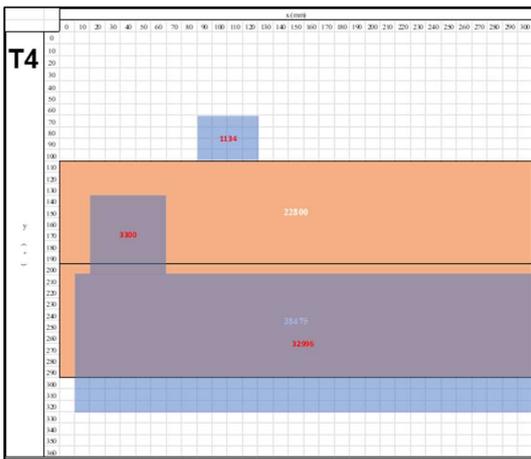
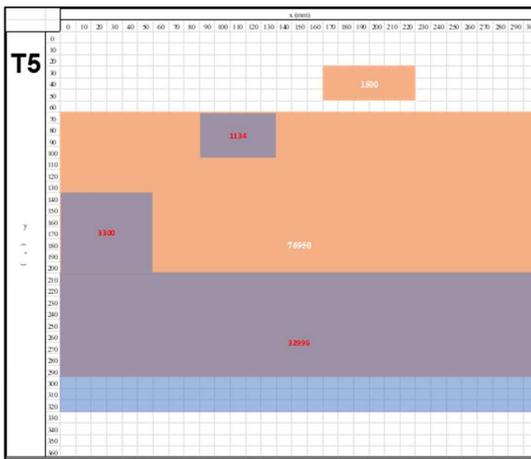
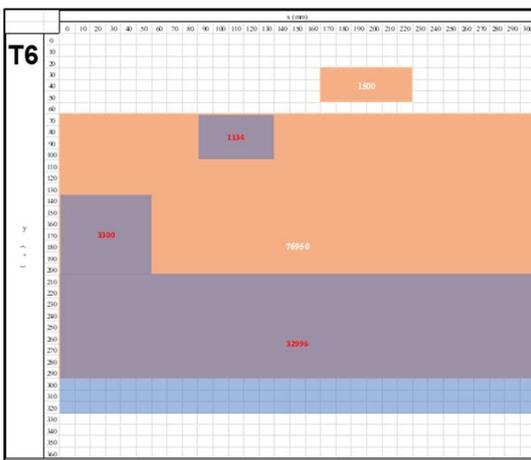
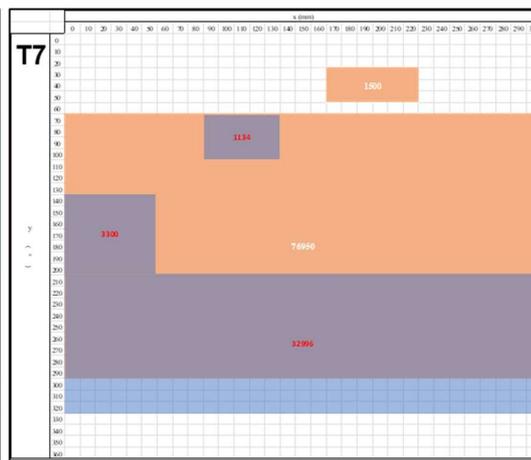
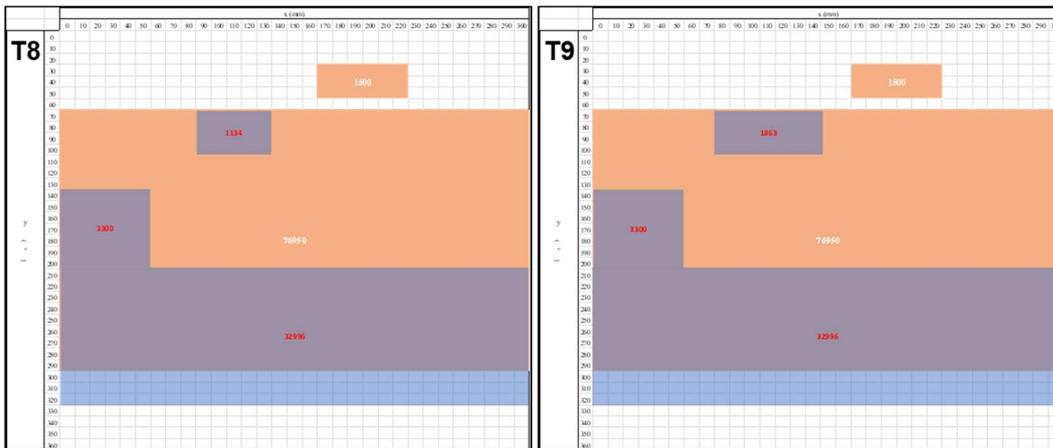
Figure 38: Evolution of detections for pipe number 6 as seen by Shearography, in orange, and Ultrasound, in blue. Numbers inside indications represent the defective area in mm<sup>2</sup>.

Figure 38 shows the detections for both techniques in sample #6. Larger images are also available at the Appendix A for better visualization. On this pipe, especially, both techniques detected similar defective areas as inspections were performed over time. In both cases, the initial detections were concentrated on the edges of the repair

at T0 and T1. At T2 shearography had already detected the defects from both edges coalescing, while UT would only observe this phenomenon at T4. Around T5 both techniques had already reached a point where the detections became stable, as previously discussed, once samples got closer to saturation. UT and SH detections were concentrated in the same two thirds of the pipe area, with the region around 0° practically free of detections. In the areas where the techniques found defects, SH indicated a much larger area as being defective.

One hypothesis that might explain this difference is that the criterion used by UT is focused only on the interface region between the steel pipe and the composite repair. Because of the gate applied for analysis, only defects in this region would have been detected, while defects that might have been present throughout the thickness of the composite repair would not have been detected. This is not the case with SH, where any defects that could be somewhere just below the surface of the repair and the steel pipe would overlap and appear to the operator as one single defective area. In the case of pipe #6, as it appeared to be a very defective sample, defects could be in the entire thickness of the material and not restricted to the interface, so SH presented a much larger indication.

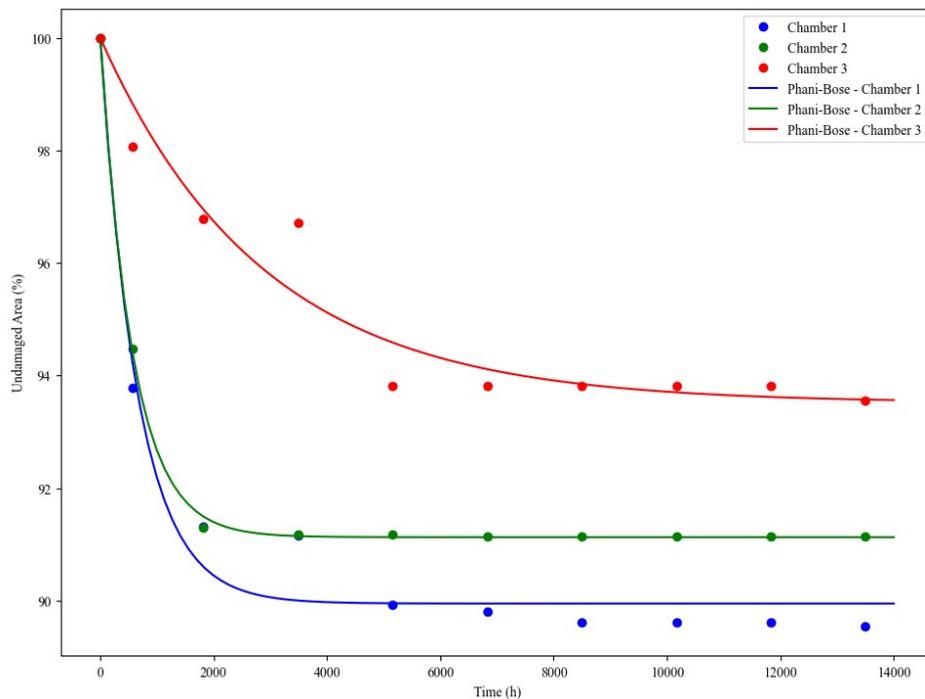
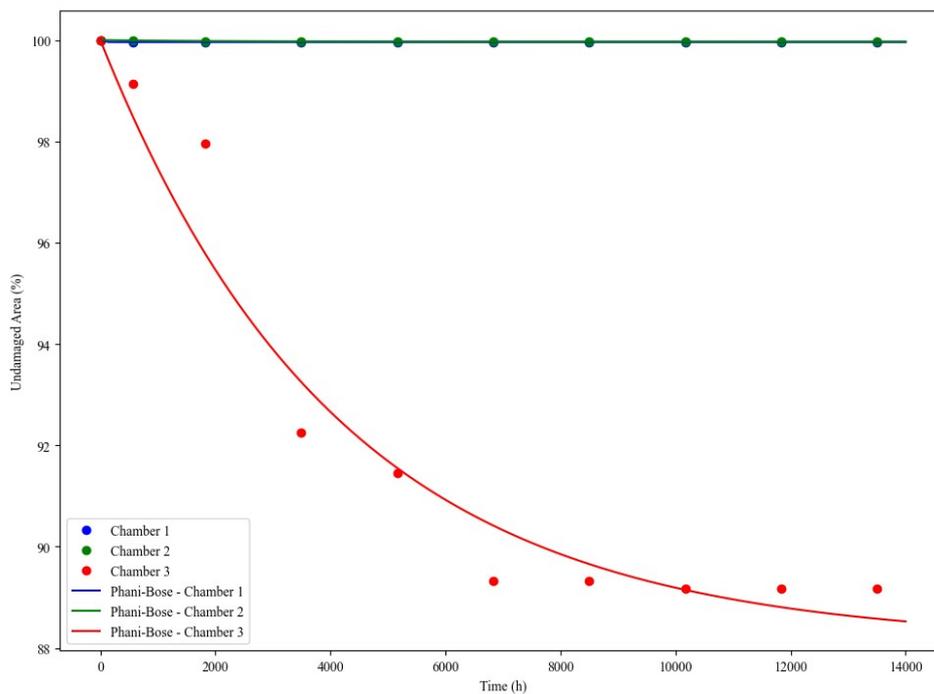
Figure 39: Experimental data and fitted curves for property retentions as a function of time in: a) UT inspection; b) SH inspection. The points for chambers 1 and 2 are almost completely overlapped, due to the similarity of the undamaged area retention values for both.

The Phani-Bose equation (Eq. 6) was used to fit the curves to the retention values as a function of time for both techniques (Figure 39) and the values for  $S_{\infty}$  and  $\tau$ , as well as the  $R^2$  for the fitted curves are given in Table 24.

The parameters  $S_{\infty}$  and  $\tau$  represent the average undamaged area at infinity and the time required for this retention to be reached at a given temperature, respectively. The fit was very good, with  $R^2 > 0.9$  for all datasets indicating that the Phani-Bose model accurately describes the behavior exhibited during testing.

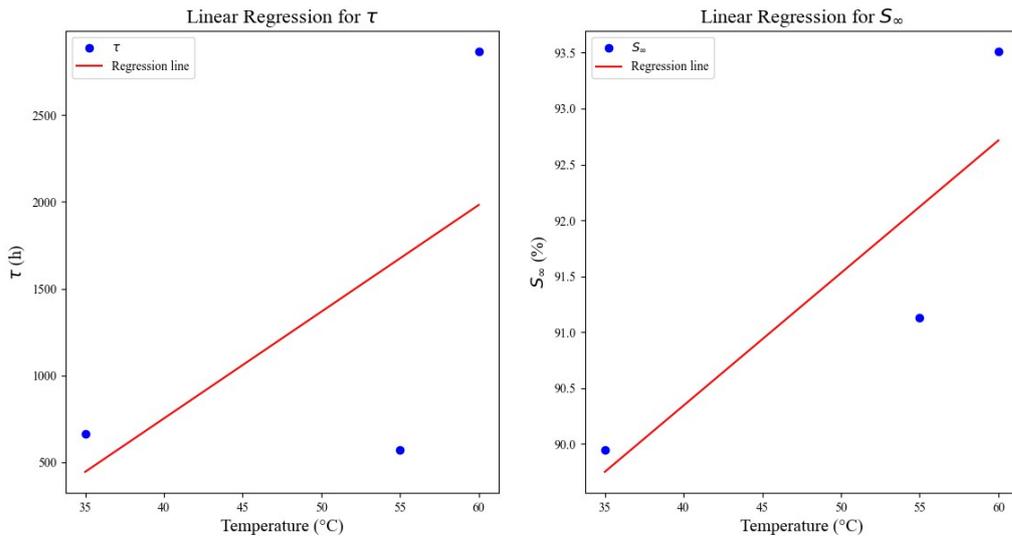
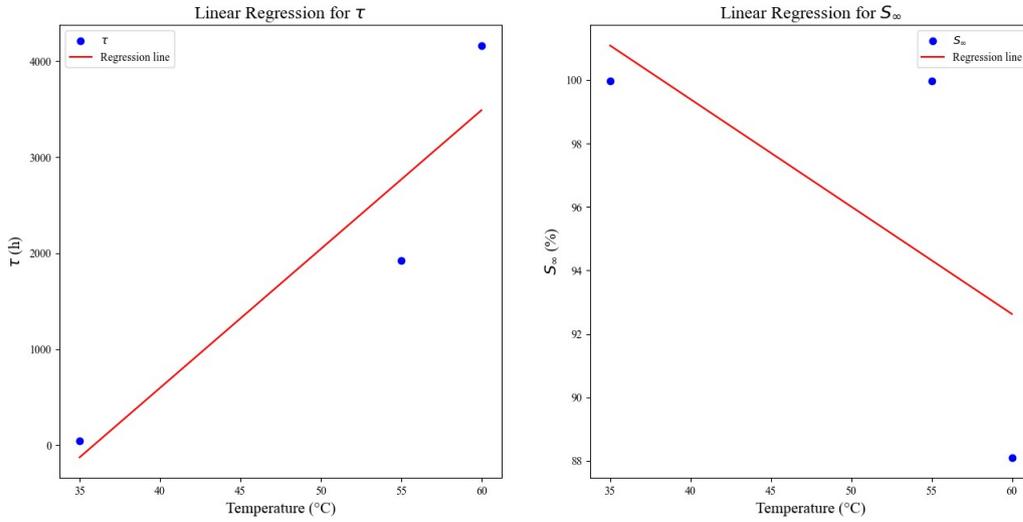
Figure 40:  $S_{\infty}$  and  $\tau$  plots based on data from: a) UT inspection; b) SH inspection

After that, both  $S_{\infty}$  and  $\tau$  were plotted as a function of temperature, Figure 40. A Python script was used to apply a linear regression method for each dataset. The parameters were listed in Table 25. With the parameters determined, the equations of the fitted curves for  $S_{\infty}$  and  $\tau$  describe how each of the variable behaves with changes in temperature, thus allowing the estimation of the effective long-term repaired area given a certain period of time and operating temperature.

Although the fit was good for some of the parameters, the information provided by the  $S_{\infty}$  and  $\tau$  plots did not reflect the expected behavior in real life. The variable  $S_{\infty}$  is expected to decrease as temperature increases, because high operating temperatures tend to accelerate degradation mechanisms and lower the property retention over time. This unexpected behavior was mainly caused due to insufficient data for each ageing condition, as only 8 pipes were analyzed from each chamber and, of these, few showed significant damage growth during the testing period. Additionally, in the case of UT, chambers 1 and 2, despite having less severe conditions than chamber 3, had a greater average damaged area at T0, which greatly affects damage propagation and may have distorted the results.
