**Comparing Ultrasound and Shearography  
inspections as methods to monitor and predict  
long-term damage propagation of composite  
pipeline repairs**

**Tese de Doutorado**

Thesis presented to the Programa de Pós-graduação em Engenharia de Materiais e de Processos Químicos e Metalúrgicos of PUC-Rio in partial fulfillment of the requirements for the degree of Doutor em Engenharia de Materiais e de Processos Químicos e Metalúrgicos.

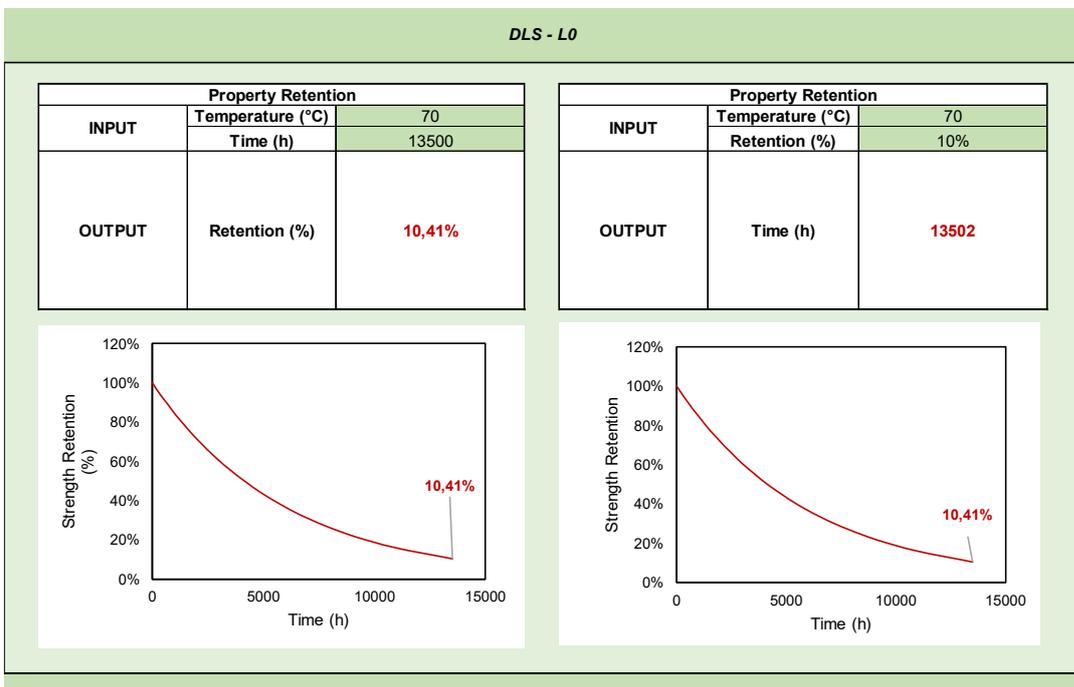
Figure 41: Property retention tool for DLS samples calculating both retention as a function of temperature and time and time to reach a certain retention as a function of temperature.

In a parallel research within the author’s research group (not yet published), the same methodology was used to estimate the retention of properties in other types of samples with success. Double-Lap Shear (DLS) and composite samples were aged under the same conditions, but with a much larger sample pool. With the results, a tool was developed (Figure 41) to help predict long-term retention of properties as a function of either temperature and time or temperature and target retention, in which case the time necessary to reach the target is calculated.

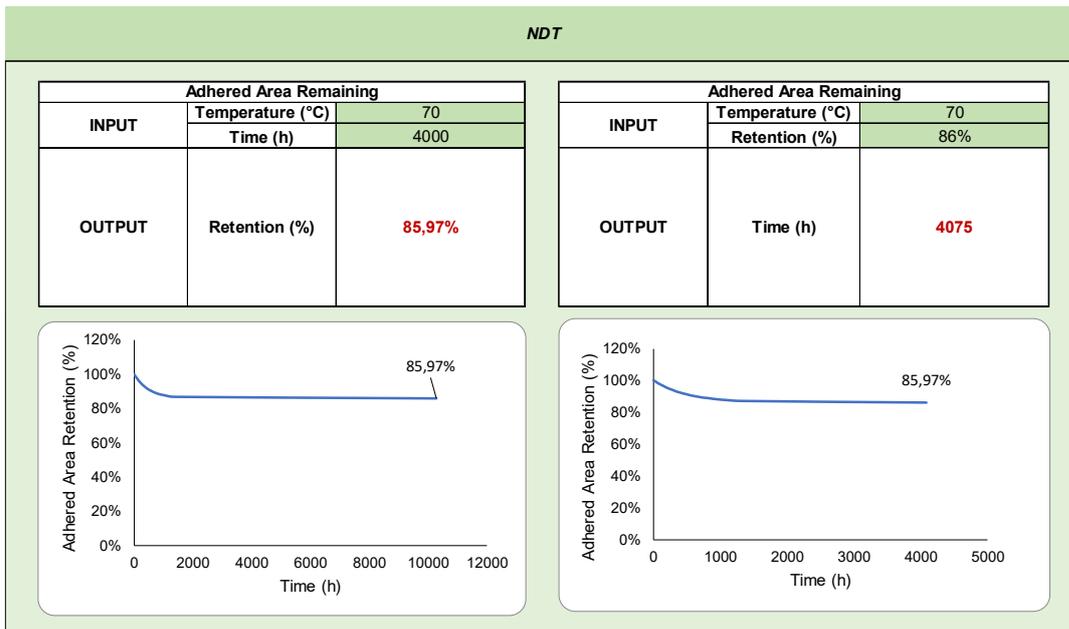
Figure 42: Initial attempts at developing a property retention tool for effective repair length, based on the Phani-Bose methodology.

The same approach was tested with NDT results on pipe samples with some degree of success, but more data needs to be input into the model for the results to be reliable enough for use in the field. A screenshot of the tool can be seen in Figure 42.
